# The Wenatchee River Delta

## A Brief History of the Land

Bruce P. McCammon  
May 2020

North Central Washington  
**AUDUBON SOCIETY**

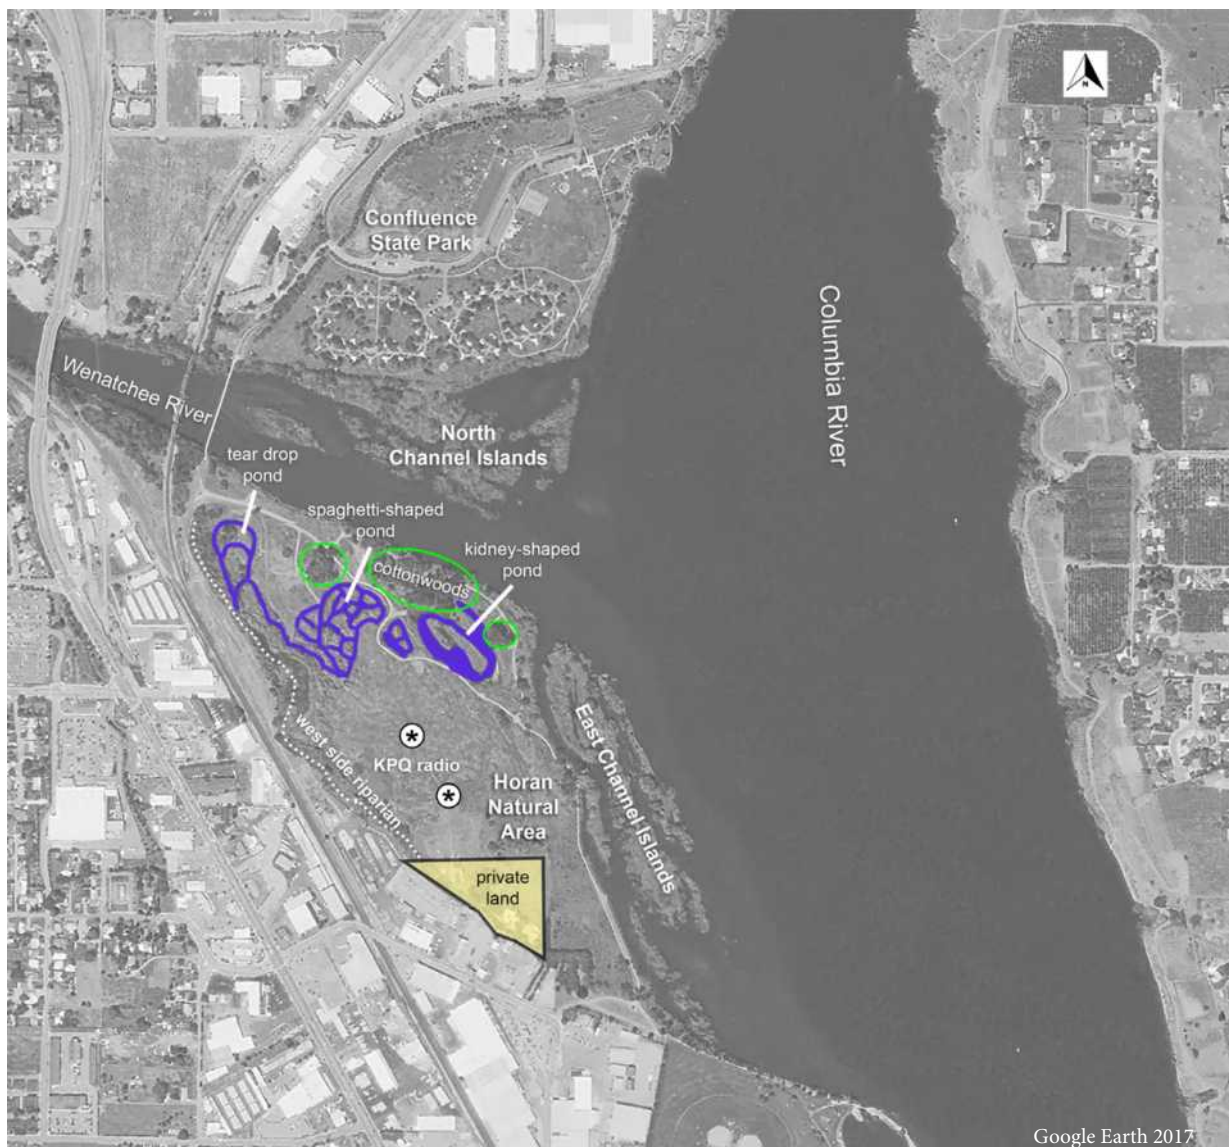
Figure 2. Commonly referred to features within the Wenatchee River delta

In this paper, commonly used references to informal feature names within the delta are shown in Figure 2. Administratively, Confluence State Park contains both the developed RV campsite on the north side of the Wenatchee River and the Horan Natural Area (HNA) on the south side. The HNA includes the area labeled “Horan Natural Area” and both the North Channel Islands and the East Channel Islands. The areas labeled Horan Natural Area and Confluence State Park are owned by the Public Utility District No.1 of Chelan County (Chelan PUD or PUD). The Channel Islands are owned by the Washington State Department of Natural Resources. Approximately six acres are in private ownership by three owners. The land around the KPQ radio towers is owned by the PUD, is part of Confluence State Park and is managed by agreement with KPQ. Both the Confluence State Park and the Horan Natural Area are managed by Washington State Parks using an agreement with the PUD.

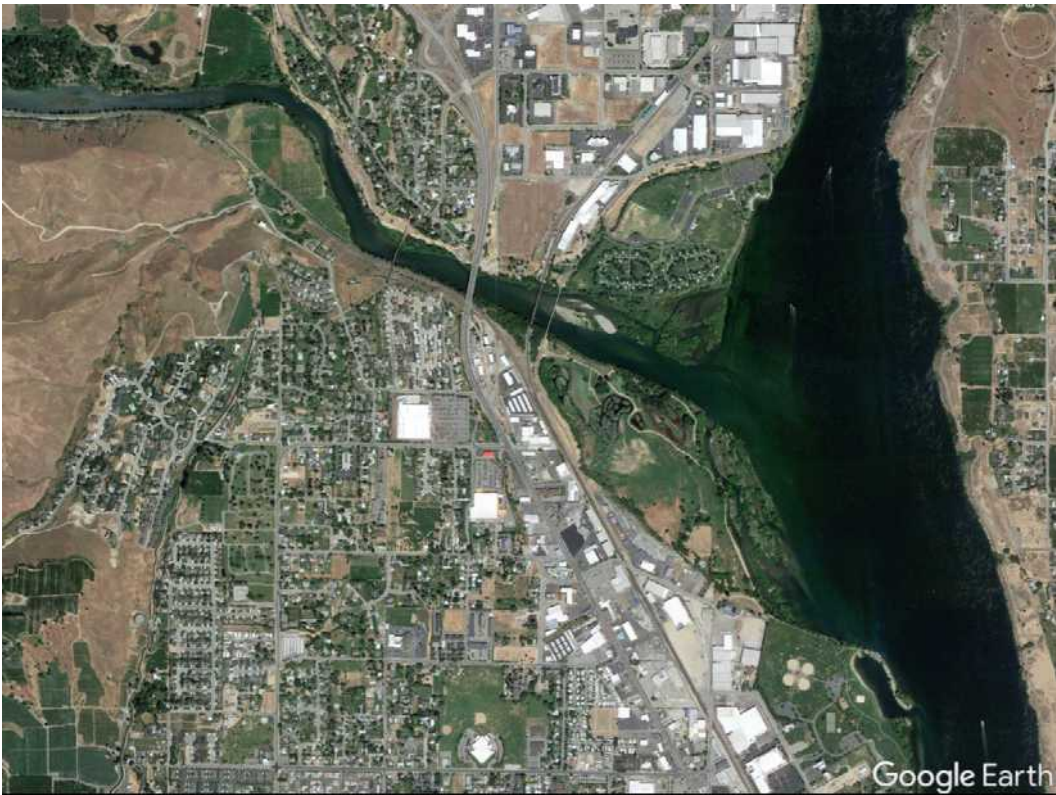
3. Lidar and satellite images - Confluence of Wenatchee River and the Columbia River

The two images in Figure 3 offer a comparison of the land surface (lidar image, top) and a 2017 satellite photo. The right side of the lidar image looks darker due to data availability through the Washington DNR.

Lidar imagery uses laser reflectance to show land elevations as a digital image. Cutting through existing vegetation, the lidar image clearly shows the Wenatchee River separating the Confluence State RV Park from the Horan Natural Area. River terraces, formed as the Columbia River cut through Ice Age flood deposits, are evident on the west side of the image. A crescent-shaped erosion scarp (dashed line) was formed as the Wenatchee River lowered its valley level as the Ice Age lakes retreated. This erosion scarp is easily seen from the paved portion of the Apple Capital Loop trail. Both the RV park and the Horan Natural Area lie at elevations 10 to 30 feet lower than the City of Wenatchee.

Both the north and east channel islands are evident in both images. The dangling point of land in the lower right corner was formed when the swimming lagoon at Walla Walla Point Park was excavated between 1964-1967.

The ponds in the Horan Natural area were created in 1990.

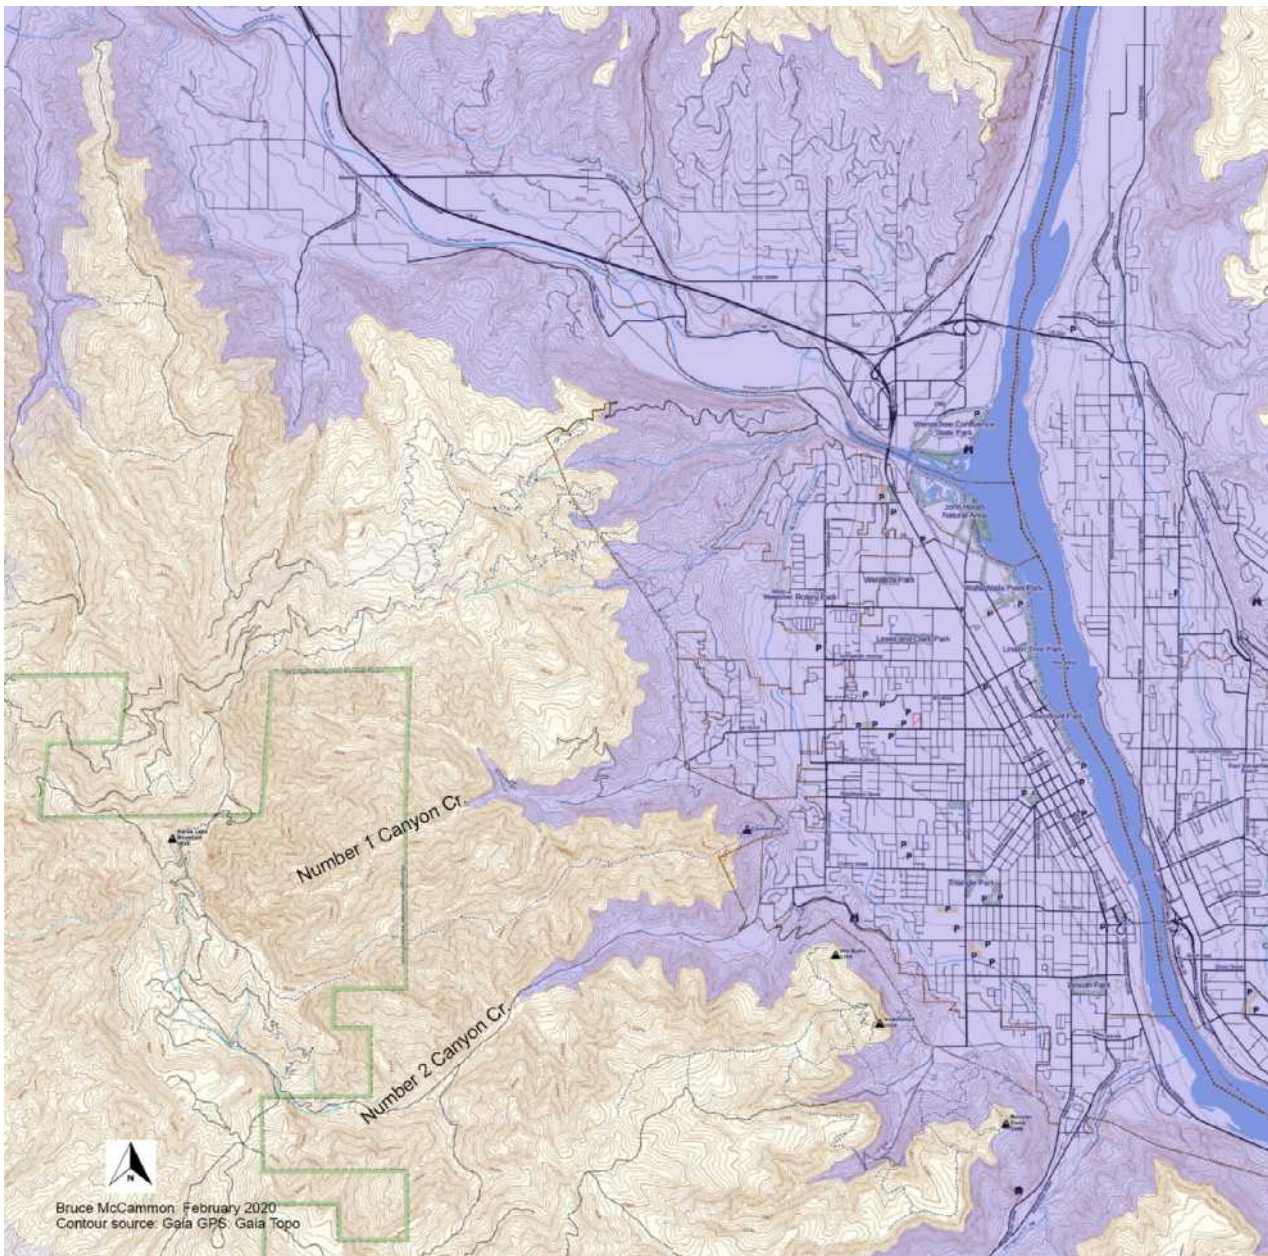
Figure 4 .Area below 1600 feet MSL showing the maximum area flooded during the Ice Age floods

Subsequent to the scouring flood(s) that raged down the Columbia River channel, the Wenatchee valley repeatedly filled with a series of back-flood lakes created when flood waters surging down Moses Coulee were restricted near the mouth of the coulee. These floods backed water up into the Wenatchee valley and then up the Wenatchee River valley to an elevation of about 1600 feet MSL (Figure 4) (Waitt, Long and Stanton, 2019). Recent literature presenting simulations of outburst floods from Lake Missoula suggests that the duration of inundation may have been a matter of weeks (Denlinger & O’Connell, 2010). Previous literature shows a much longer period of inundation (Gresens, 1983).

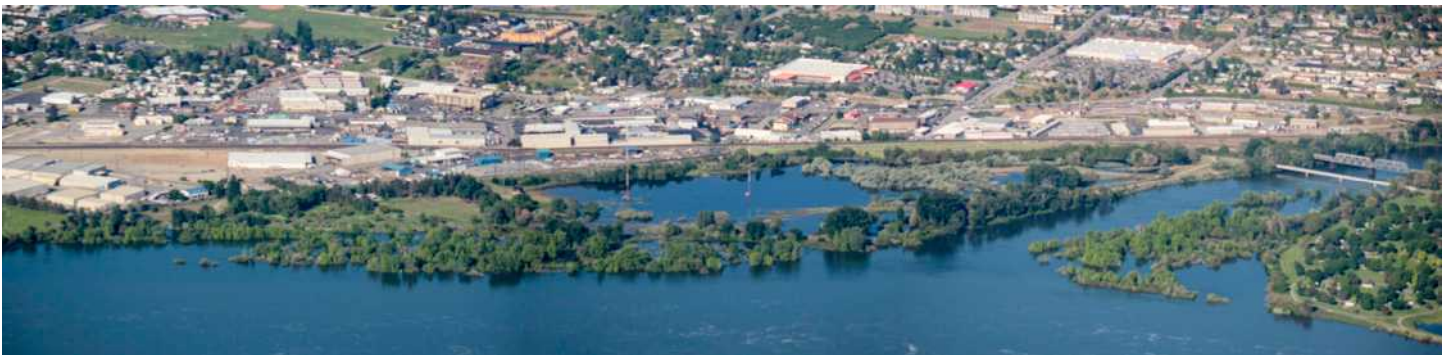
Figure 6. Flooding of Horan Natural Area May 18, 2018. (Courtesy of Lisa Robinson)

The Wenatchee River delta is subject to localized flooding. Before dams regulated flows in the Columbia River, both the Wenatchee and Columbia Rivers experienced frequent flooding. Even with dam regulation, very high flows in the Columbia River create localized flooding in the HNA. In May, 2018 snowmelt in Canada caused high flows in the Columbia River and flooding of much of the Wenatchee River delta (Figure 6). Water flowed from the Columbia River into the Horan Natural Area through a culvert placed in 1990. As the Columbia River continued to rise, water entered by over-topping the banks of the Columbia River. The Wenatchee River remained within its banks and was not a direct source of flood waters in this event. Flood waters reached depths of several feet around the radio towers in the center of the HNA (Figure 7). Much of the flood water had retreated by June 2, 2018.

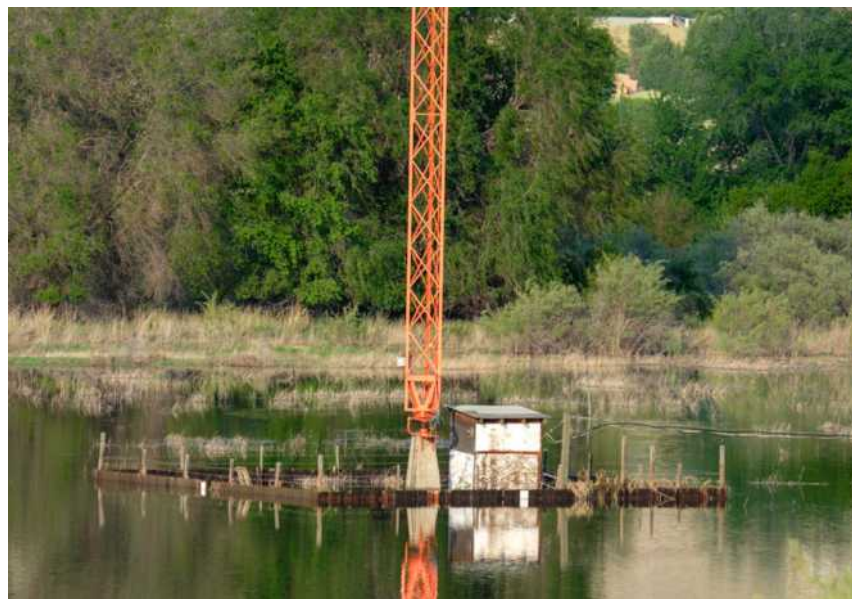
Figure 7. May 15, 2018 Flooding near radio tower in the Horan Natural Area

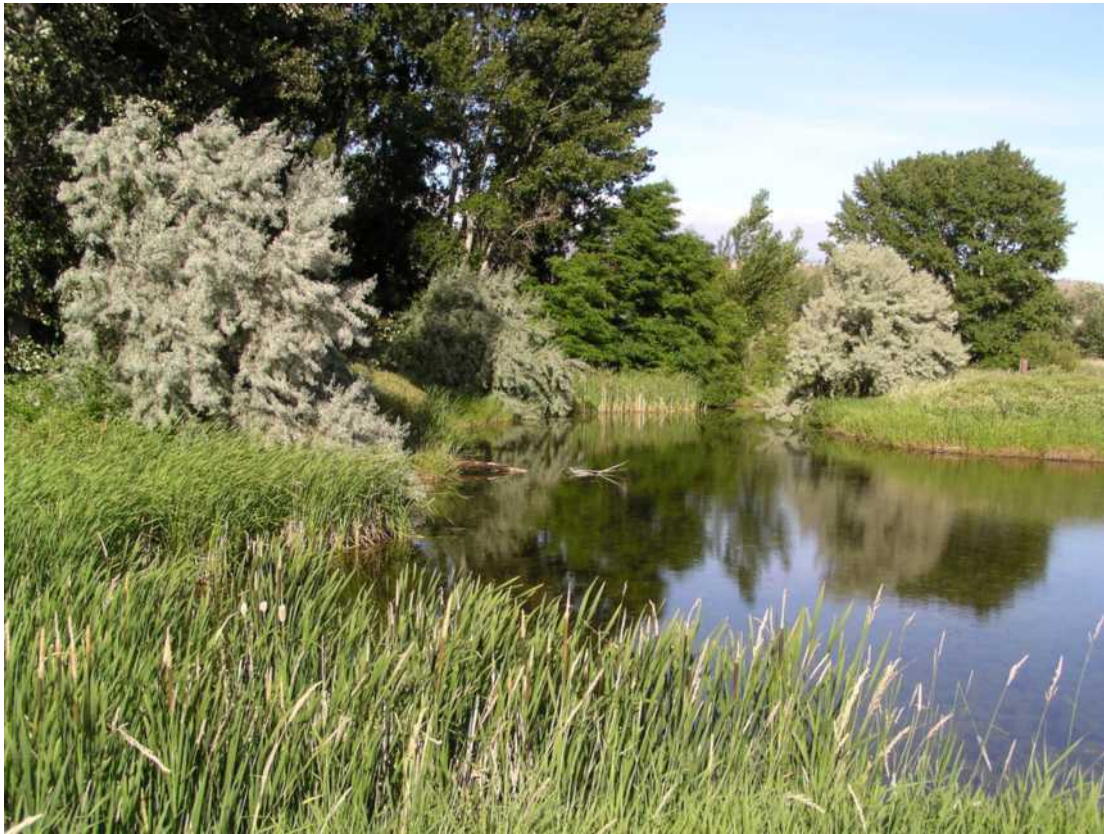
*Figure 8. The north end of the kidney-shaped pond when full, ca. 2008. The view is to the E-SE. (courtesy of Mark Oswood)*

The value of reliable surface water flowing into the ponds is captured quite nicely in Figures 8 and 9. Aesthetically and ecologically, water makes all the difference. When the last substantial surface water into the HNA was terminated in 2012, the ponds became reliant on groundwater which, in turn, is a function of the level of water flowing in the Wenatchee and Columbia Rivers.

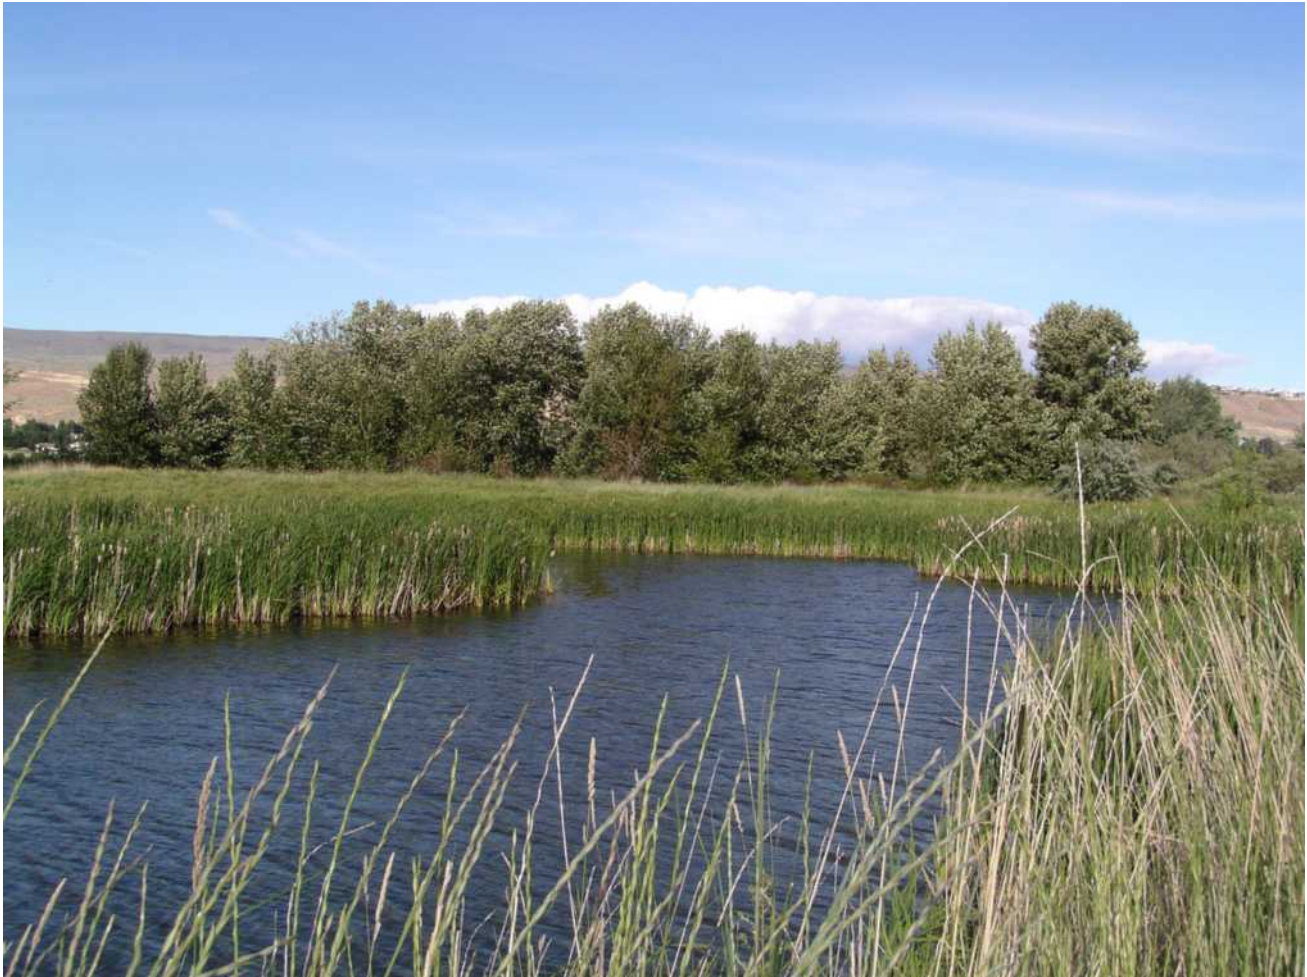
*Figure 9. Full pond in the Horan Natural Area, 2003. (Courtesy of Mark Oswood)*

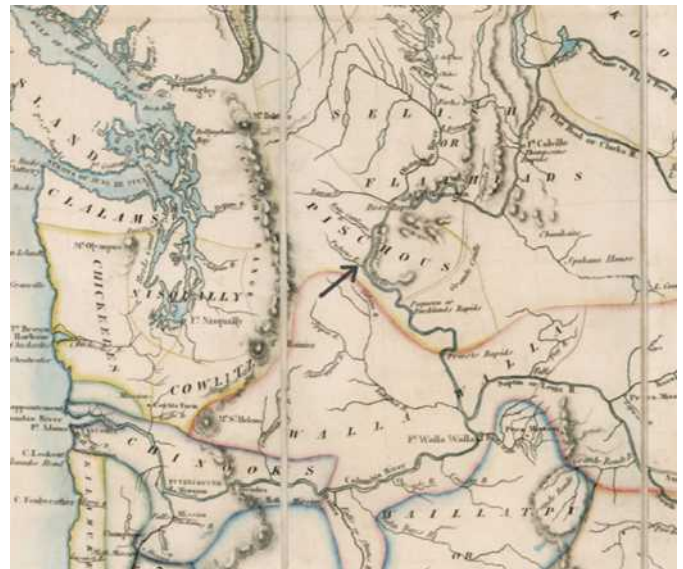
Figure 11. Excerpt from 1841 map created by Charles Wilkes

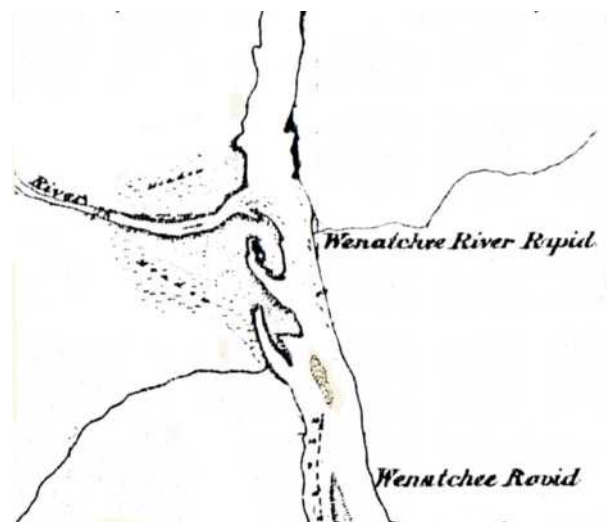
Figure 14. Excerpt from Alfred Downing's map of the Wenatchee River confluence, 1894

Captain Symons organized a second survey of the Columbia River from the Canadian border to Rock Island in 1894. This survey was conducted by C.F.B. Haskell and Alfred Downing was, once again, the cartographer for the excursion. The 1894 expedition resulted in a set of maps that provide early information about the character of the land at the mouth of the Wenatchee River (Figure 14).

- The Wenatchee River is shown entering the Columbia River and veering slightly to the north.
- Two other nearby tributary streams are shown – one entering the Columbia from the east near the label “Wenatchee River Rapid” and another from the southwest. The stream on the east side of the Columbia is most likely the unnamed canyon that Eastmont Avenue spans by bridge today. The stream entering the Columbia River from the southwest is likely Number One Canyon Creek.

- Note the designation of “meadow” along both sides of the Wenatchee River. These areas form a similar C-shaped crescent seen in the lidar image in Figure 1.

- The two finger-like extensions of the Columbia River south of the Wenatchee River illustrate what may be remnant channels of the Wenatchee River, both of which extend up and to the west from the bank of the Columbia River.

- The illegible markings near the west bank of the Columbia River at the bottom of the diagram are depth sounding records documented by Haskell and Downing.

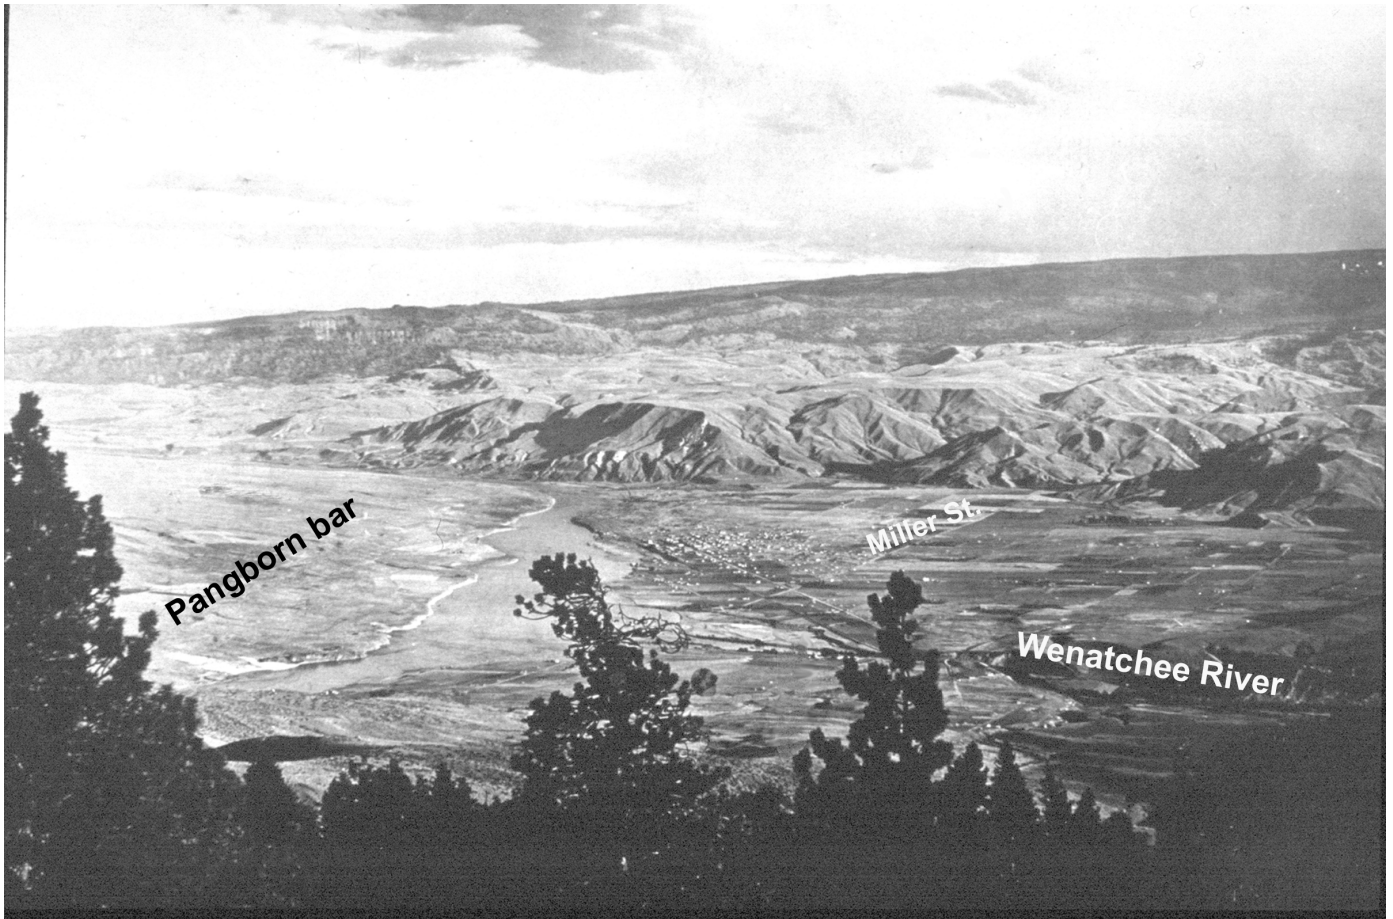
The photo below (Figure 15) was taken circa 1900. The view is looking southwest from Burch Mountain. It shows the Wenatchee River flowing into the Columbia River from the west. The photo clearly shows the “...level plain some mile or so broad, and just opposite the blue Wenatchee...” (Wood, 1886-1887). This photo allows us to easily imagine thousands of Indigenous Peoples camping in the area and conducting a horse race along the bank of the Columbia where East Wenatchee sits today.

*Figure 15. View from Burch Mountain ca. 1900  
(courtesy of the University of Washington Libraries and William Layman). Annotations added by the author*

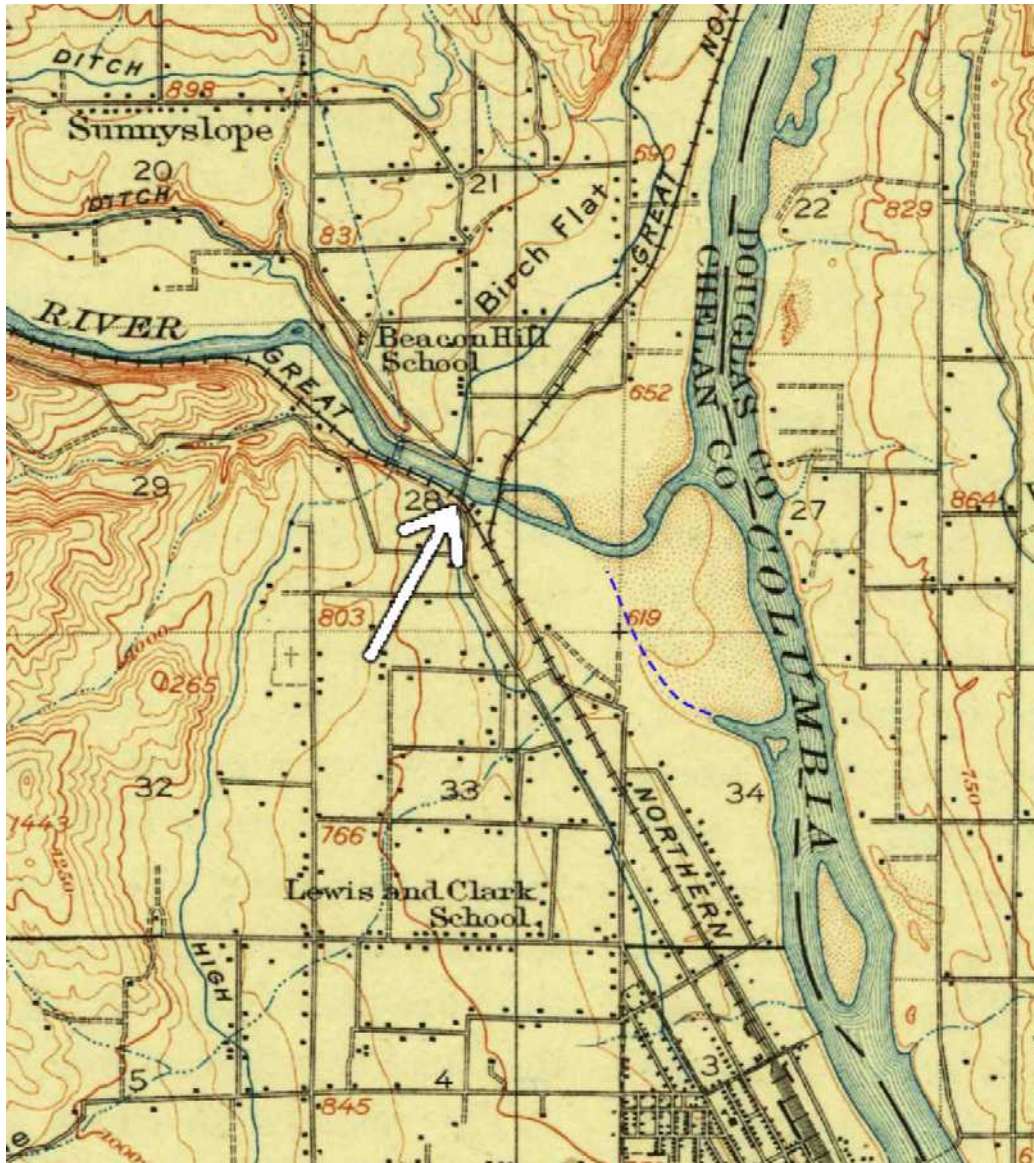
Figure 16. Excerpt from 1915 USGS 1:62500 map, Wenatchee quadrangle

Figure 16 shows a portion of the 1:62500 scale map published by the USGS in 1915. The 1915 USGS map shows the extent of the delta on both the north and south sides of the Wenatchee River. Features of interest are:

- The Wenatchee River flows decisively to the north before entering the Columbia.
- The globular landform extending into the Columbia can easily be translated into the Native American reference as “the otter paw”. Moat of the material washed in during the 1894 flood. (Randy Lewis, personal communication, 2020).

- An inlet of the Columbia River is seen jutting into the delta above the label of Section 34. This is the same channel extension shown as the southern-most channel in the sketch map made by Downing in 1894. A single contour crenulation aligns with the surface water feature and clearly suggests a remnant channel of the Wenatchee River (blue dashed line) that would have flowed near, or through, the elevation mark “619” at the northeast corner of Section 33.

- The arrow points to a bridge just west of the railroad crossing. This bridge was built in 1895 (Rader and Behler, 2012). Figure 17 is a photo of the bridge. The bridge served people on the north side of the Wenatchee River, including Sam Miller and the Burch family residing in the Olds Station area.

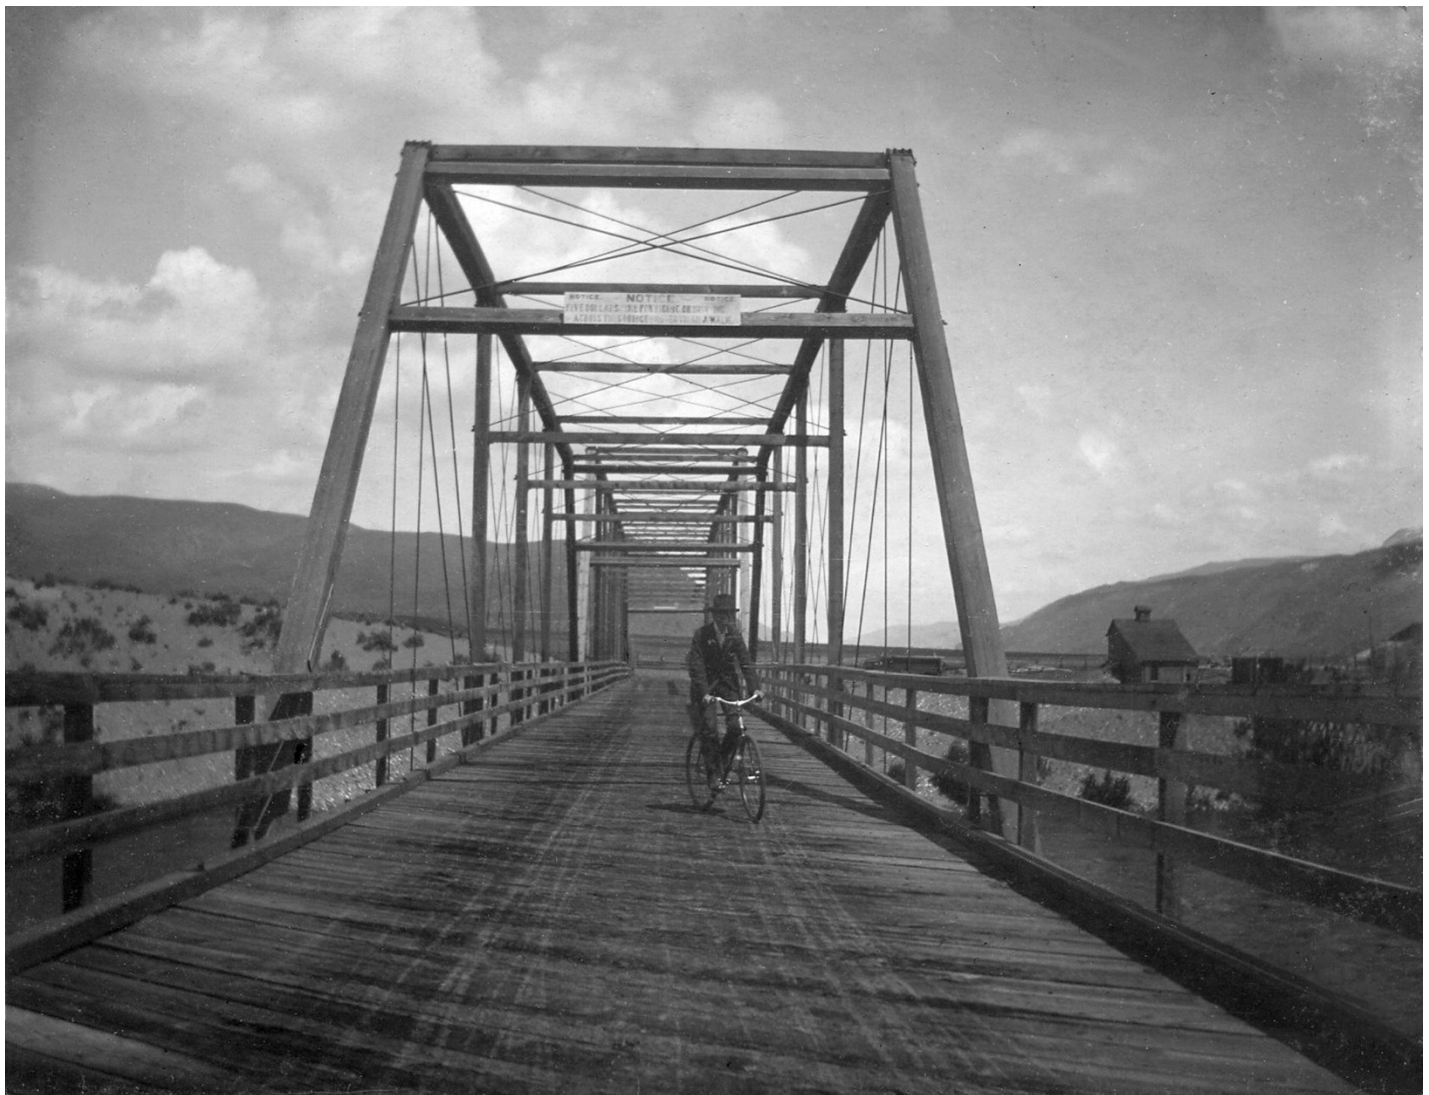
What had to be the first bridge to span the Wenatchee River (Figure 17) was built by Isaac Bailey in 1892 (Rader, 2018). The bridge washed out during the great flood of 1894 and was rebuilt in 1895 (Rader and Behler, 2012). This is the bridge that is pointed to in Figure 16. The bridge began at the northern end of what is Duncan Road today and extended north across the river to Horan Road in the vicinity of Sam Miller's cabin and farm. The north end of the bridge was adjacent to the Horan House when it was built in 1900. A support footing for the bridge is still evident in the center of the Wenatchee River during low flows.

*Figure 17. 1895 bridge over the Wenatchee River (WVMCC 85-0-87)*

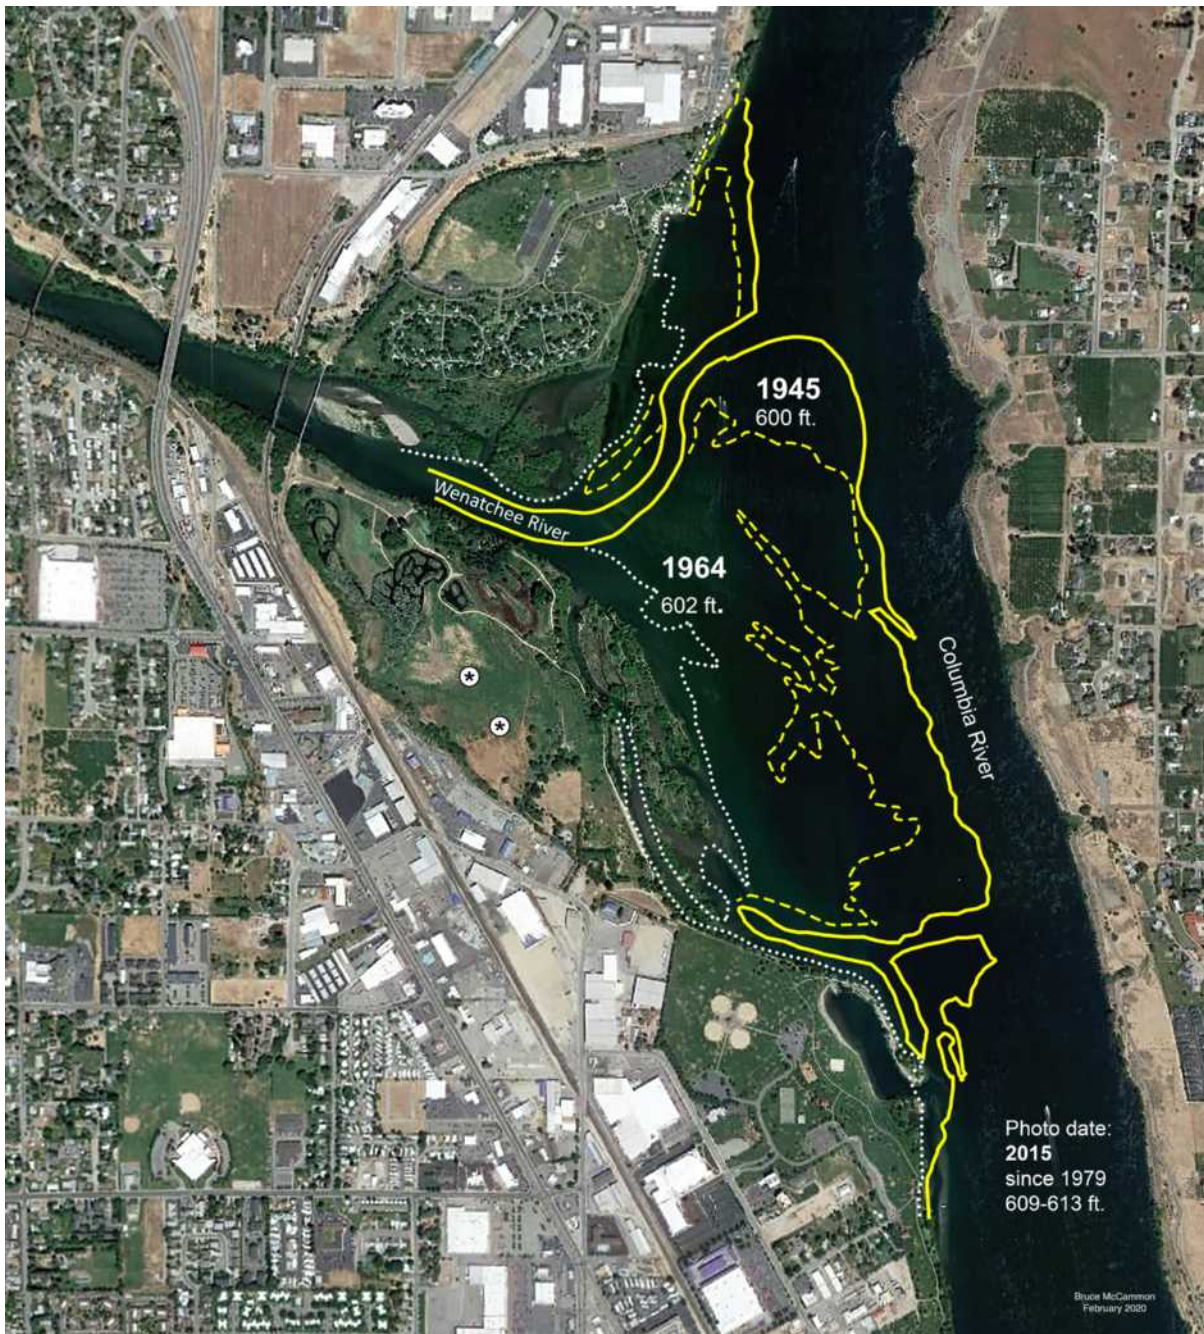
Figure 19. Areas of the delta inundated over time 1930-2015

Figure 18 shows the incremental inundation of the delta due to changes of the operating pool over time. The delta perimeter lines shown are from available photos that are closest to the date of changes in the elevation of the operating pool at Rock Island Dam.

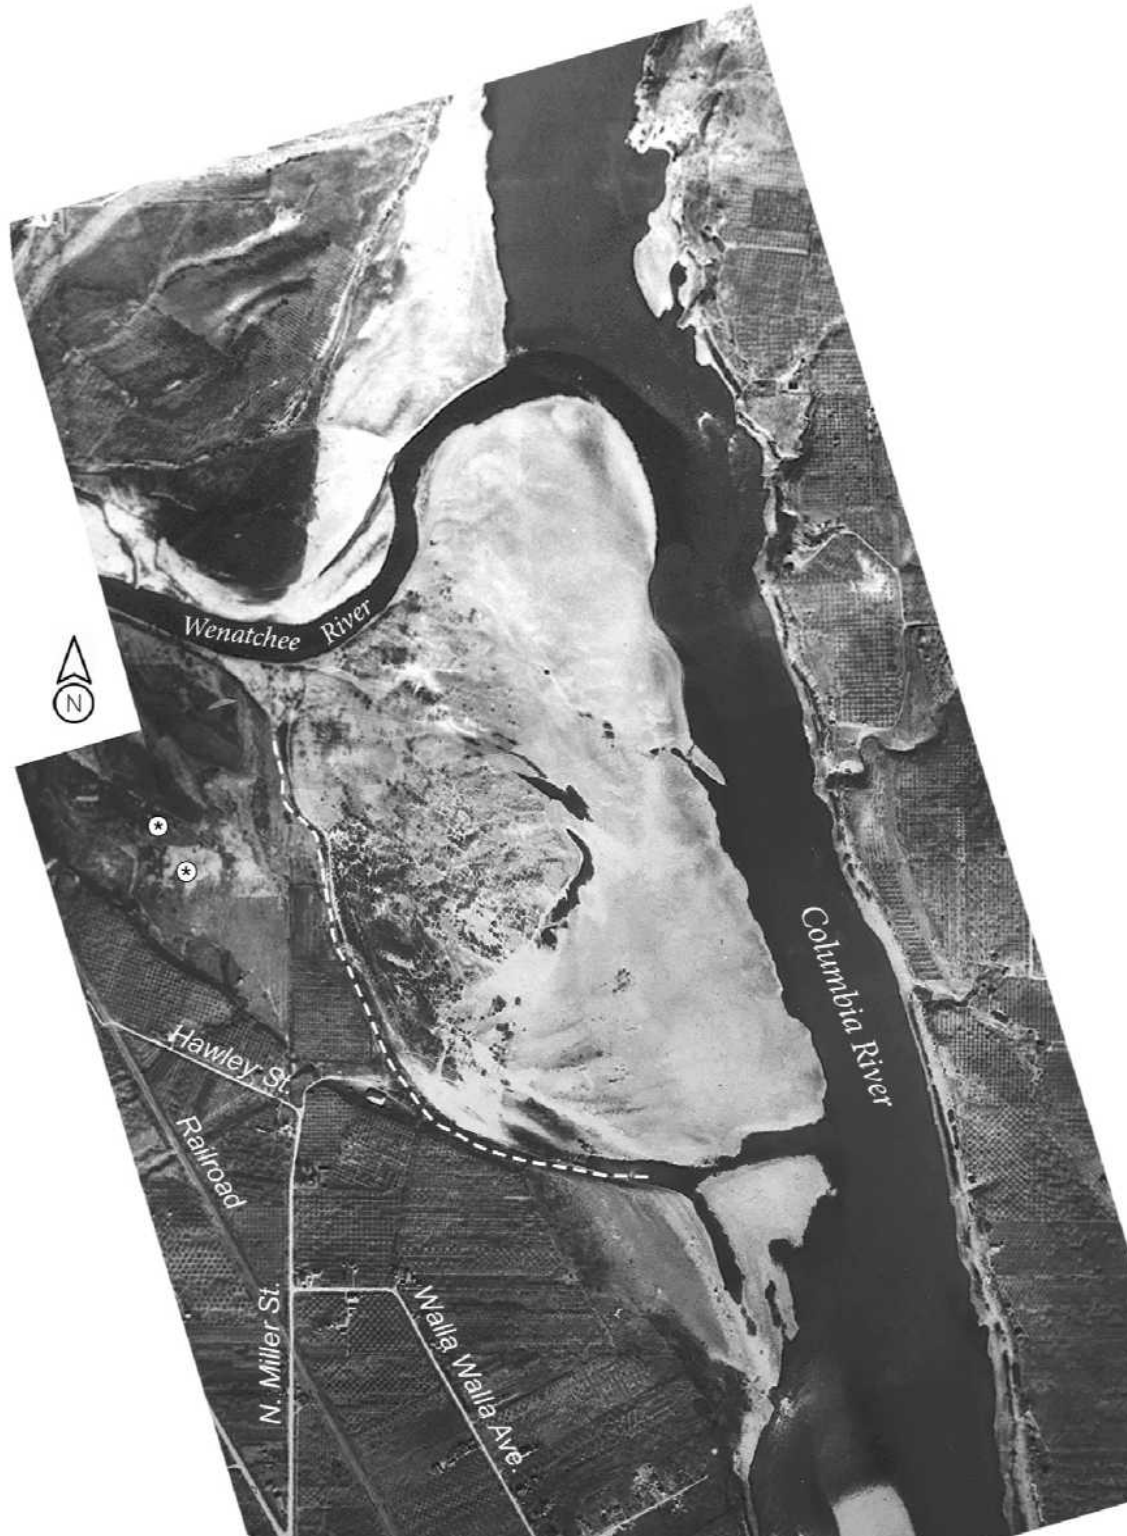
Figure 20. 1930 Brubaker Aerial Survey photo composite (courtesy of William Layman)

The first vertical aerial photo of the Wenatchee River delta (Figure 19) was prepared by Brubaker Aerial Surveys in 1930 for the U.S. Army Corps of Engineers. Street names and the location of the KPQ radio towers have been added for orientation. A dashed line highlights a historic Wenatchee River channel that ran along what becomes the eastern edge of the Horan Natural Area as we know it today.

The Brubaker photo is the only known vertical image of the Wenatchee River delta prior to the completion of the Rock Island Dam in 1933. The photo provides significant information about the area that is not seen in the USGS topo map. Unfortunately, the photo does not show any of the bridges crossing the Wenatchee River.

Key features of the 1930 photo include:

- An historic Wenatchee River channel (dashed line) that extends from the Wenatchee River, south to the Columbia River. This is the same channel shown in the 1894 Downing sketch (Figure 14) and in the 1915 USGS topographic map (Figure 16). The channel forms a separation between lower elevation alluvial deposits and higher elevation lands to the west. This channel evolves into the east side of today's Horan Natural Area after Rock Island Dam is raised to today's normal pool level (609-613 feet MSL).

- About half of the delta is apparently devoid of vegetation. This is likely due to the area being lower elevation than the portion to the west and, therefore, subject to regular high flows in the Columbia River. The area immediately to the east of the dashed line is sparsely vegetated indicating infrequent flooding.

- Two lower elevation ponds form a gentle arc on the east side of the vegetated portion of the delta. These ponds may be remnants of another historic Wenatchee River channel. It may, in fact, be possible to envision this channel being the northern water spur into the delta that is seen on Downing's 1894 sketch map (Figure 14).

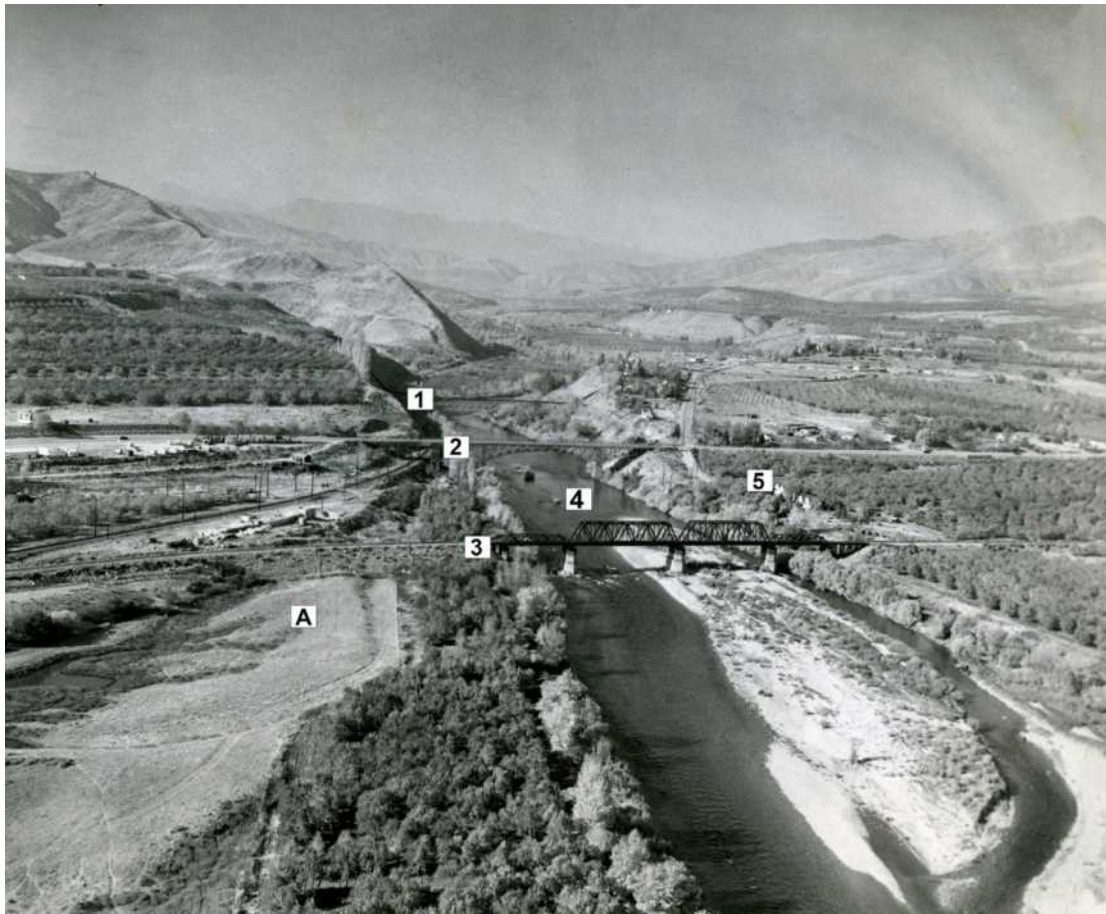
Figure 21 is an aerial oblique press photo taken in 1949. The view is to the west, up the Wenatchee River. The Highline Canal and Gunn Ditch pipeline bridge (1), 1932 Highway 285 bridge (2), and the 1912 railroad bridge (3), and are clearly seen. The only evidence of the historic bridge that ran to the Horan House is the footing for the center support (4). The Horan House (5) is seen on the north bank of the Wenatchee River.

Figure 22. 1949 view of the Wenatchee River above the Columbia River. (courtesy of William Layman)

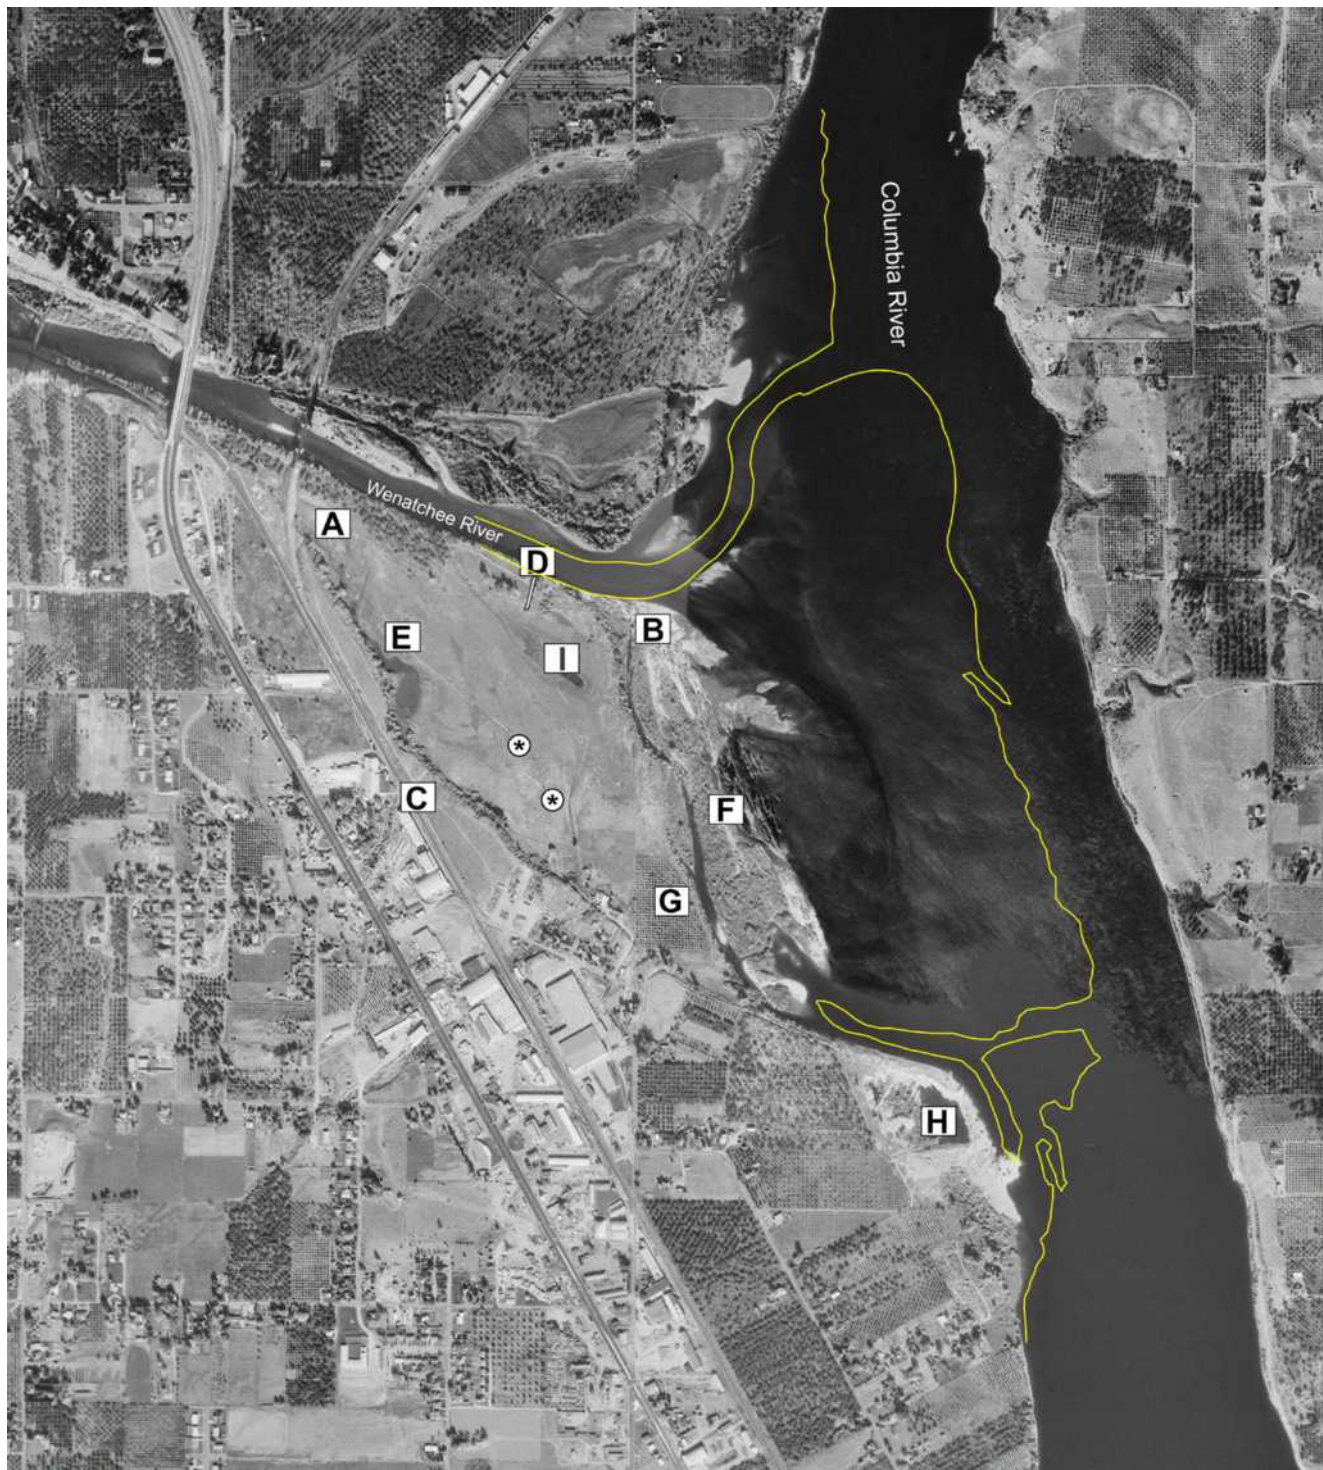
*Figure 23. 1964, prior to 1964 Christmas flood*

The pool level behind the Rock Island Dam was raised to 602 feet MSL in 1953. This increase resulted in an additional 21% inundation of the delta. 37% of the 1930 delta is now under water (Figure 23).

**H.** It appears that excavation of the swimming lagoon has begun.

**I.** A small pond area has formed in a natural depression. This area becomes a kidney-shaped pond (see Figure 2) in 1990 when the Chelan PUD constructs a series of steep-sided, connected ponds in the area.
