# The Wenatchee River Delta

## A Brief History of the Land

Bruce P. McCammon  
May 2020

North Central Washington  
**AUDUBON SOCIETY**

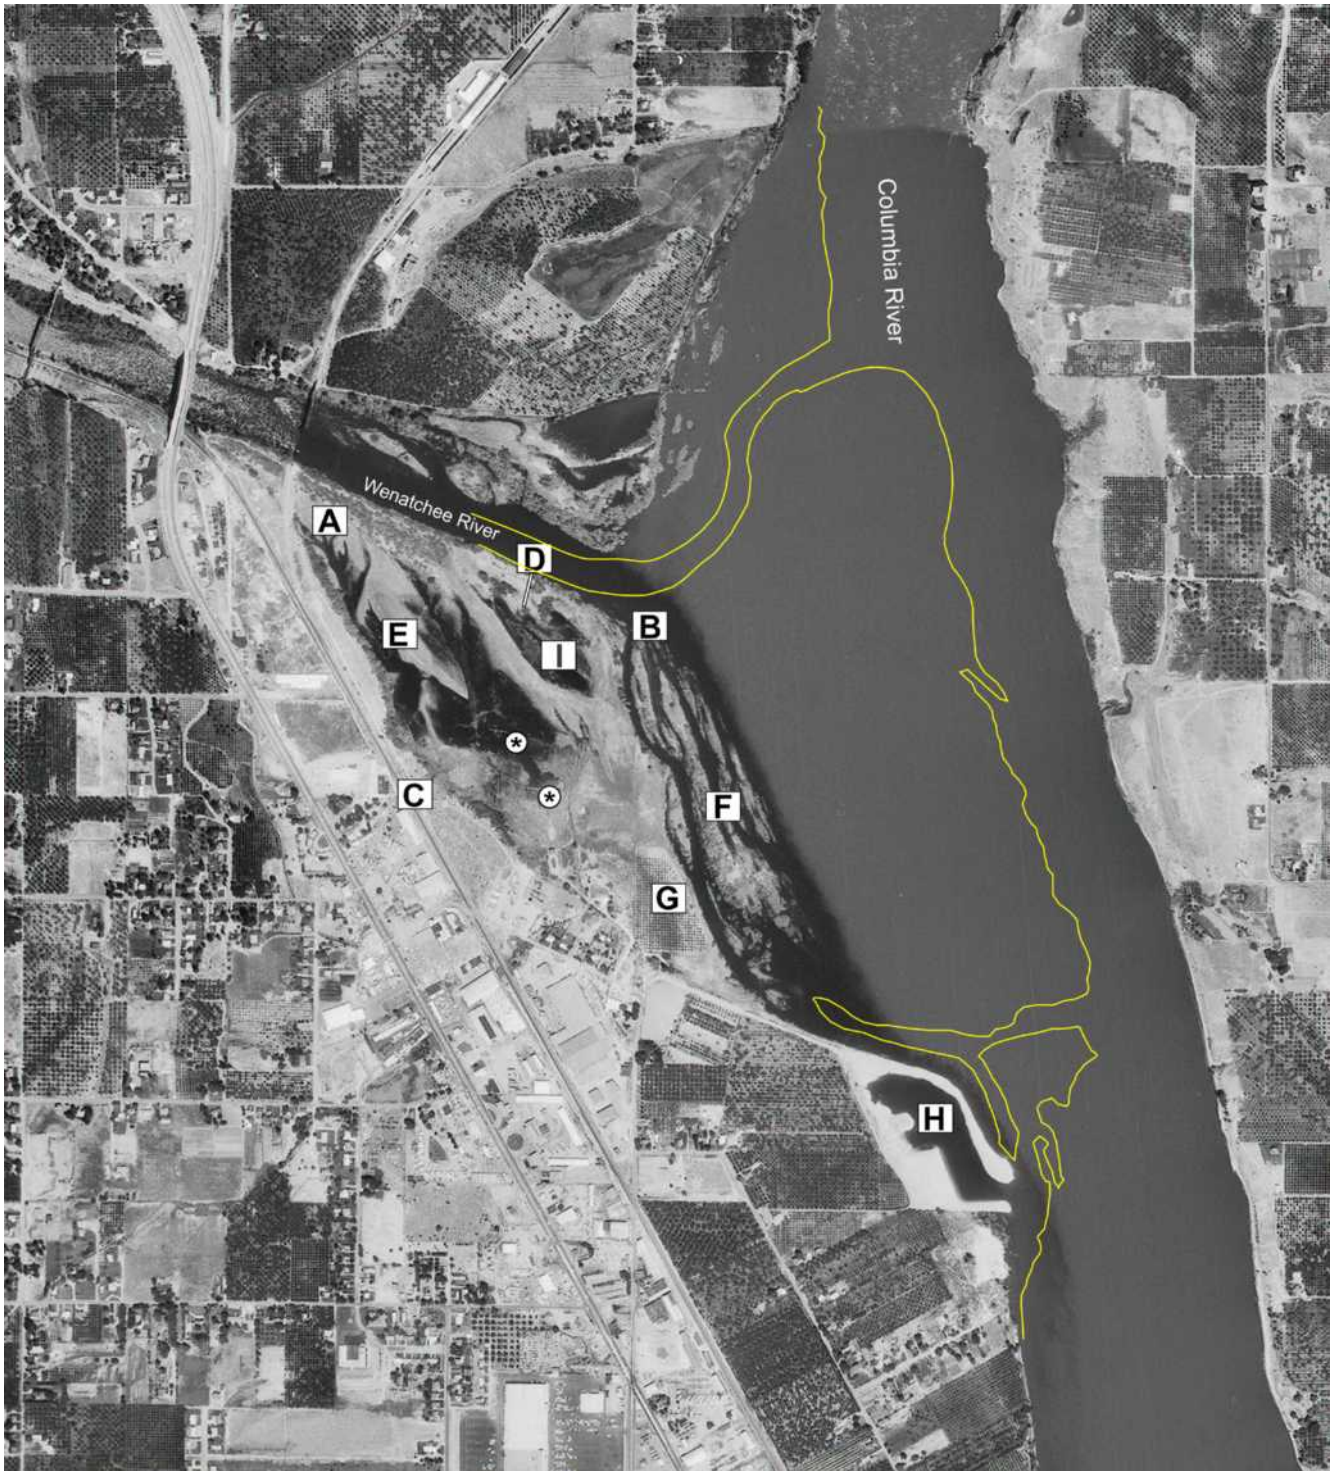
*Figure 24. 1967. After the 1864 flood and peak flows in 1967*

The photo in Figure 24 was taken about 2.5 years after the major regional flood that occurred around Christmas, 1964. The USGS Wenatchee River at Monitor gage peaked at 19,400 cubic feet per second (cfs) on June 21, 1967, just prior to this photo's creation. This peak flow is larger than that experienced in 1964 (18,200 cfs). Based on USGS streamflow data for the Wenatchee River at Monitor, there have been twenty-five years, including 1967, with higher peak flows than that which occurred in 1964.

- I.** There is a natural depression filled with water. This area is excavated in 1990 to become the kidney-shaped pond (Figure 2).

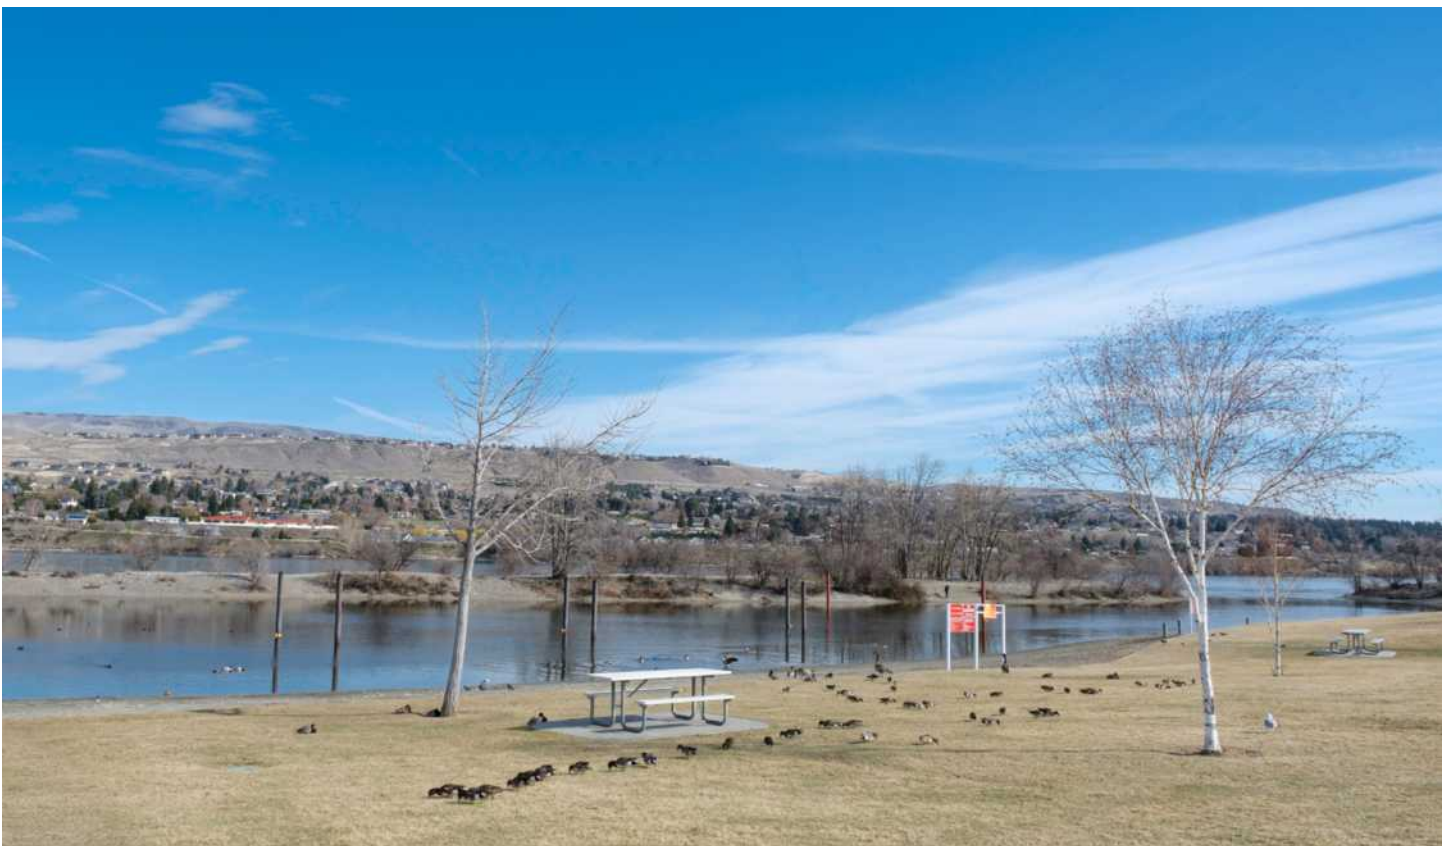
*Figure 25. Swimming lagoon at Walla Walla Point Park. The Columbia River is beyond the spit of land. February 2020*

- F.** The channel-islands are fully a part of the Columbia River
- G.** The historic orchard continues to decline
- H.** The Chelan PUD has constructed a swimming lagoon in preparation for the development of Walla Walla Point Park (Figure 25). The spit of land dangling into the Columbia River is a remnant of the delta after excavation removed material from the swimming area. Water in the lagoon does not refresh easily since water in the lagoon is connected to the Columbia River at the south end but not at the north end.

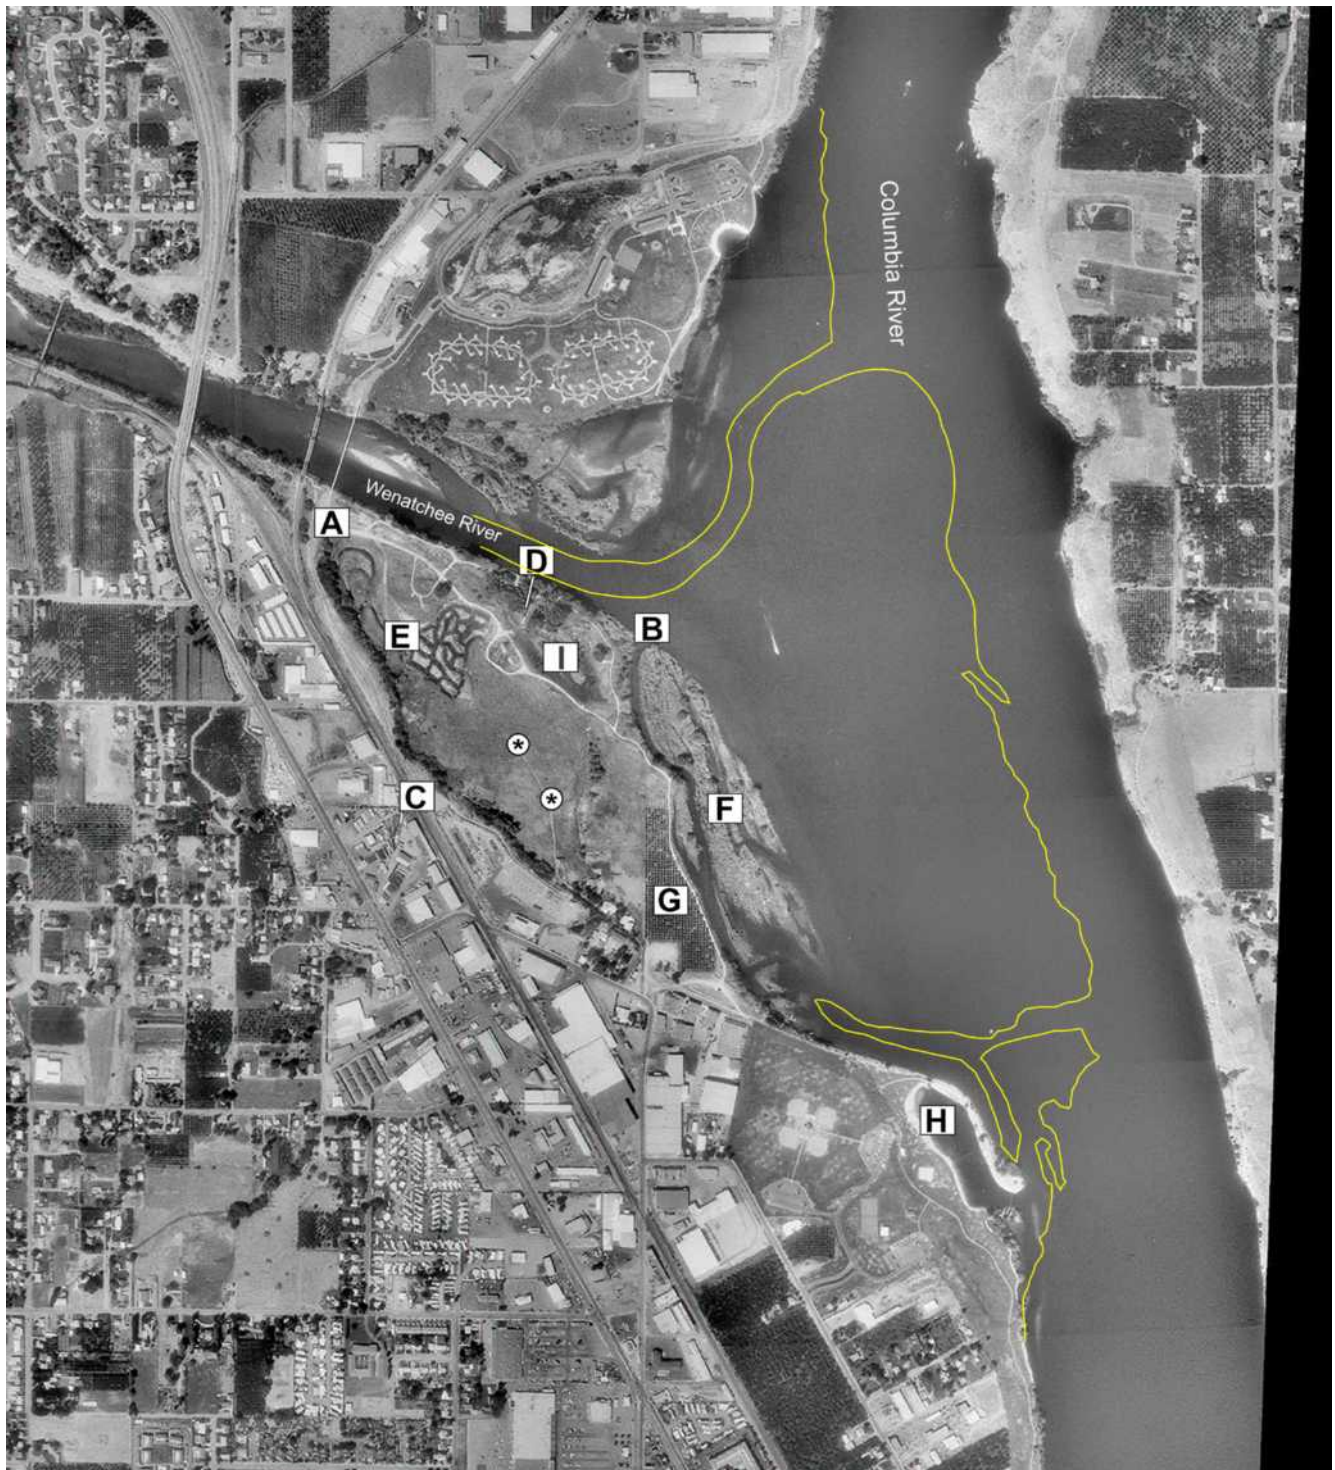
Figure 26. 1991 - many changes are evident

Figure 26 shows many substantial changes affecting the delta:

- I. The kidney-shaped pond (Figure 2) shows signs of vegetative encroachment. This shallow pond is totally consumed by cattails and grasses by 2019.

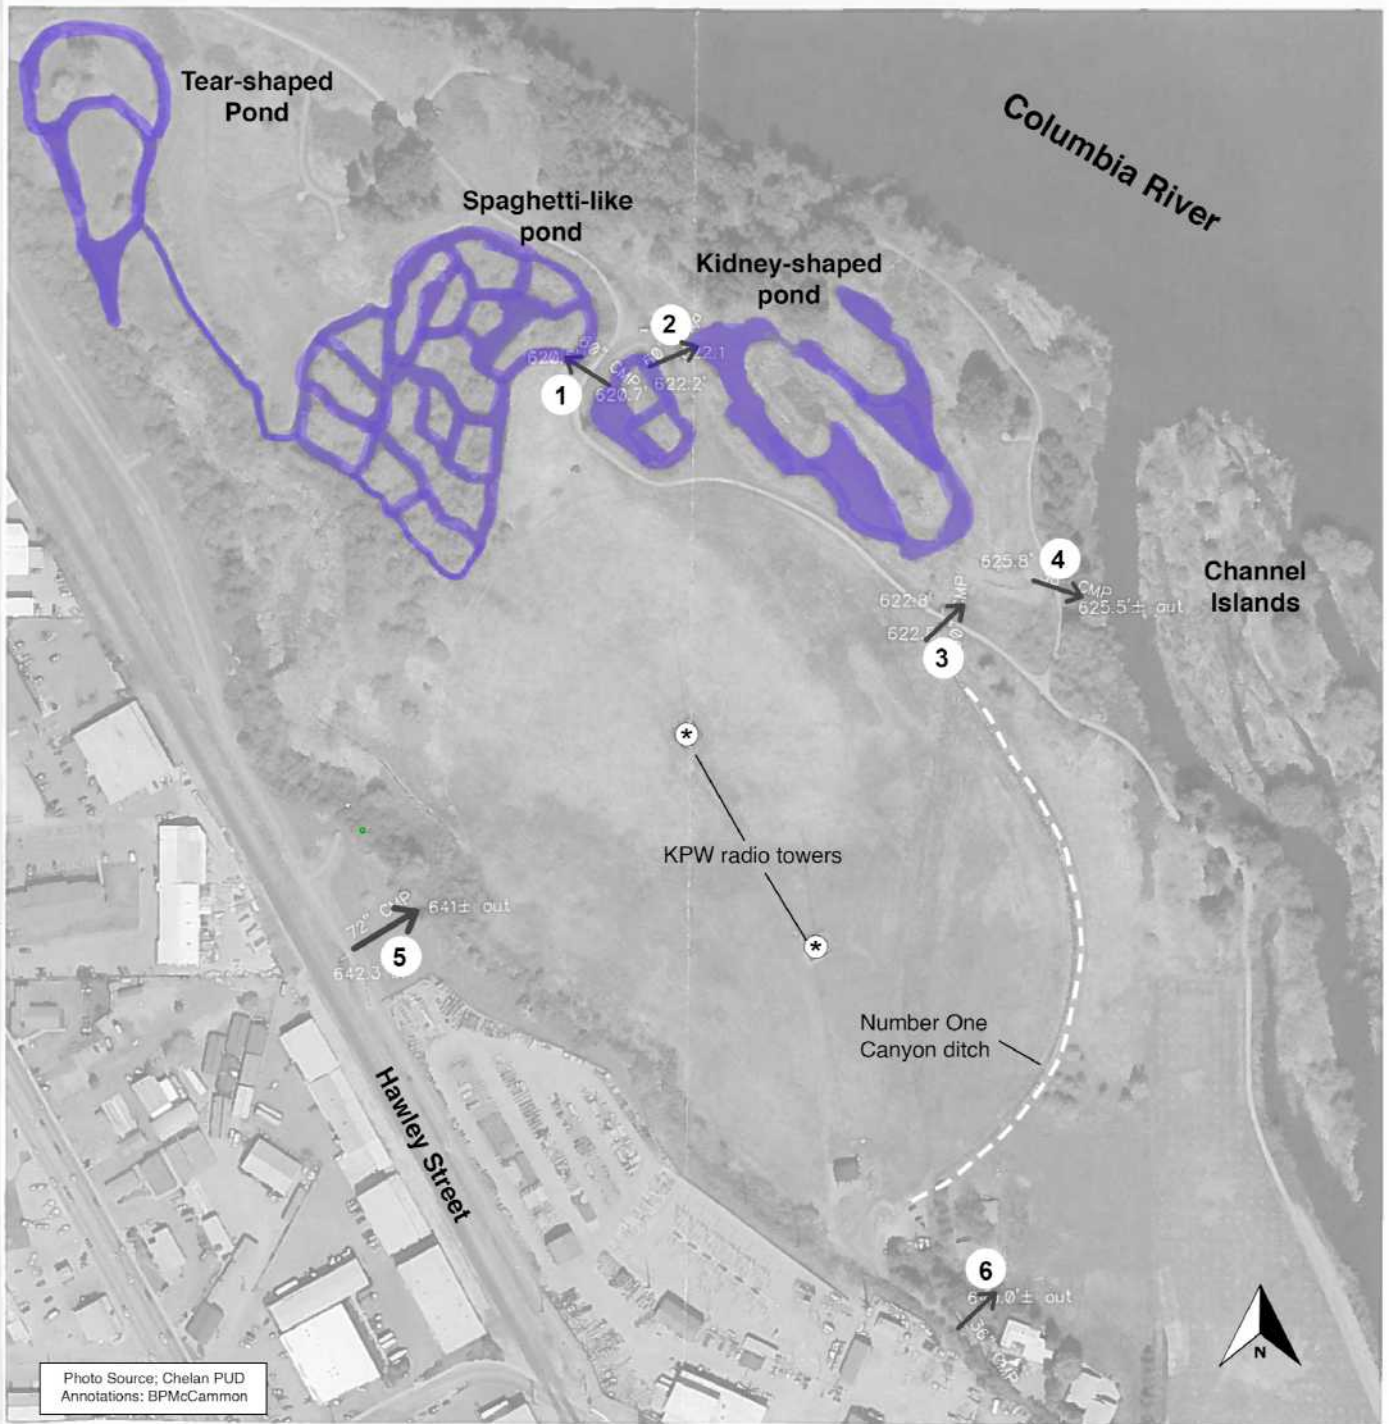
Figure 27. Culvert locations. Arrows show flow direction based on inlet and outlet elevations. Chelan PUD, 2006

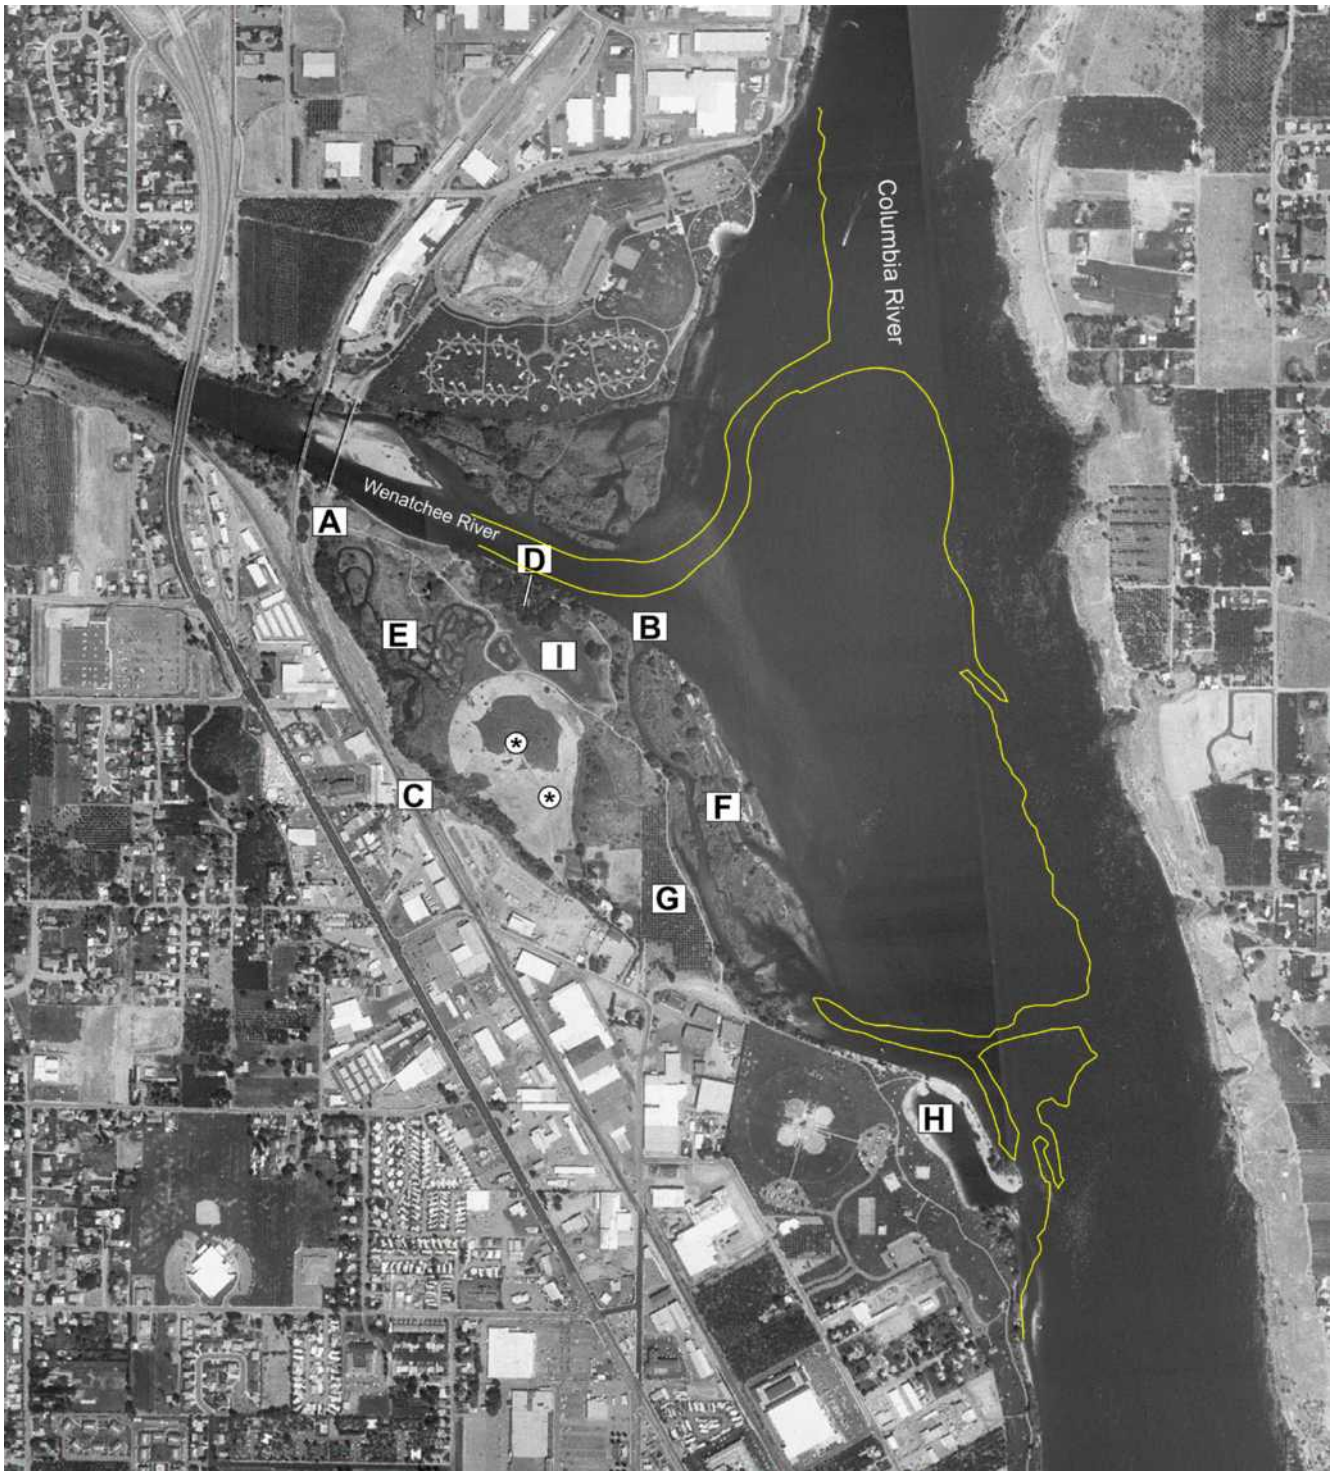
Figure 28. 1998

The kidney-shaped pond (Figure 2) at I appears to be dry. Very little change is evident at any of the other labeled sites in the HNA. The most notable area in Figure 28 is the area that is scalped or mowed around the 1928 KPQ radio towers. There is a circular array of wires at the base of each tower that is designed to amplify the radio signal transmission (Battison, 2008). The scalped, bright area roughly bounds the area that is currently restricted from public access by a fence and signs. All of the cottonwood groves have expanded, including the ones to the west of letter **A**.

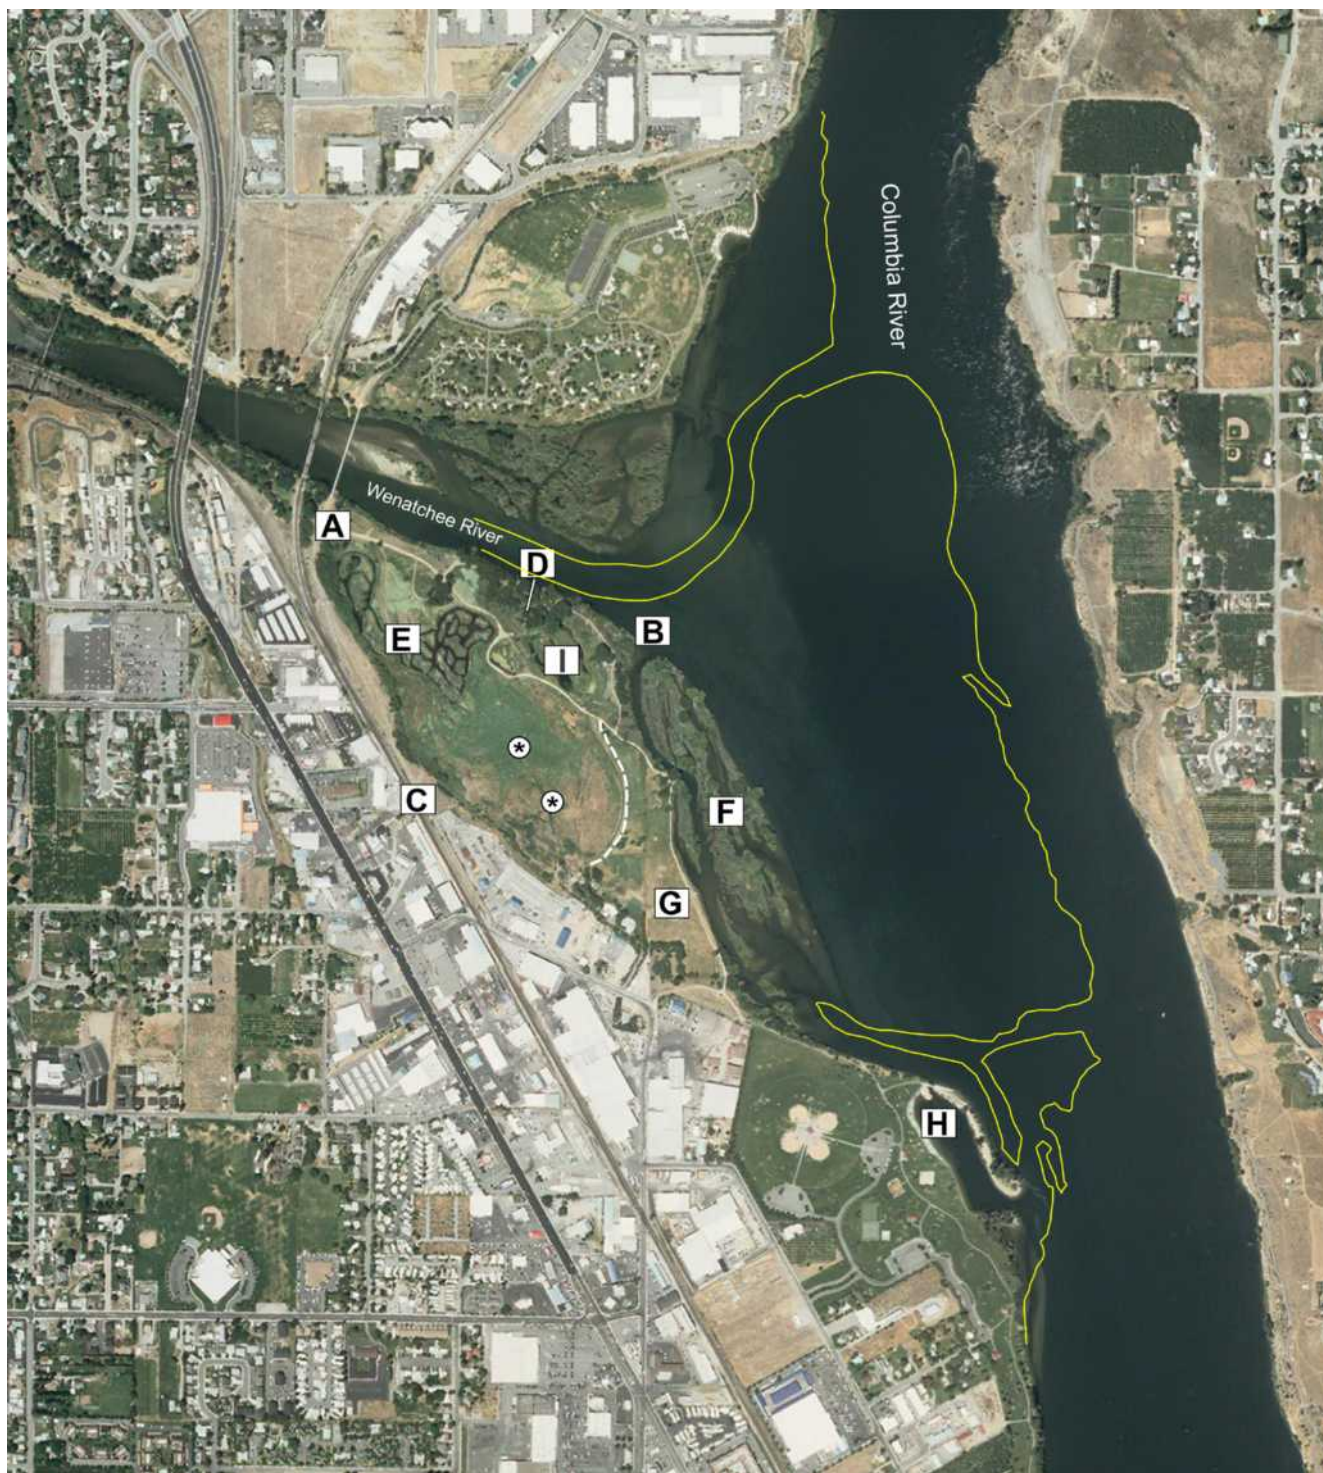
Figure 29. 2006.

May 19, 2006 was the date of the 2006 peak flow (24,200 cfs) in the Wenatchee River at Monitor. The flow was substantially higher than in 1967 (19,400 cfs). This photo (Fig. 29), taken two months later, shows little effect of the high flows that would have been present in the HNA. Unlike in 1967 (Figure 22), when large areas in the center of the HNA were inundated, this image shows no large standing water areas other than the created ponds. Number One Canyon Creek (white dashed line) has, between 1998 and 2006, been channelized to avoid the KPQ radio tower ground array area. Flow in Number One Canyon Cr. is routed under the path and then out of the HNA into the Columbia River. Vegetation is reestablished on the KPQ tower site. The cottonwood groves at label D are mature. City storm water does not enter the Horan Natural Area as of 2005.

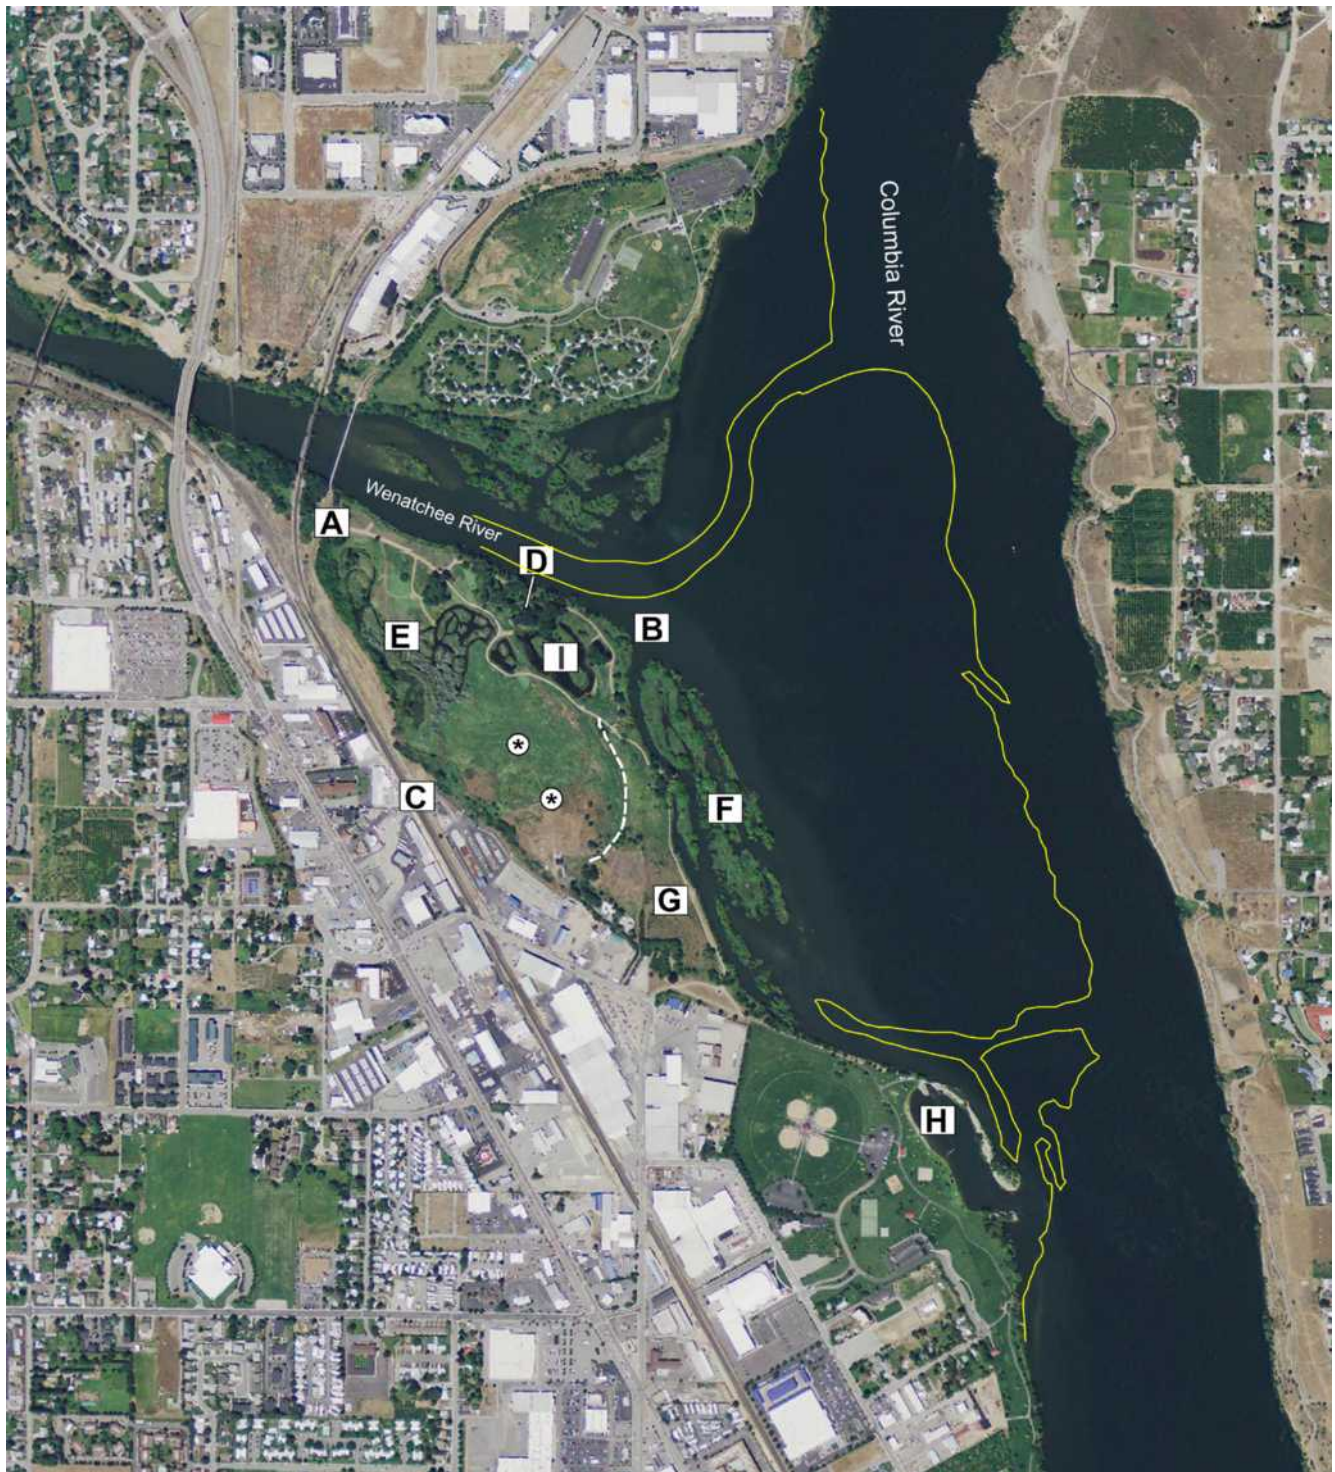
*Figure 30. 2013*

The kidney-shaped pond (I) is full in the 2013 photo (Figure 30). All surface water sources flowing into the HNA have ceased with the exception of the intermittent flows of Number One Canyon Creek. Surface water in the HNA is supported by, and responds to, fluctuations in groundwater levels resulting from changes in streamflow levels in the Wenatchee and Columbia Rivers. Pioneer Ditch water was placed in a pipe and no longer enters the Horan Natural Area as of 2012.

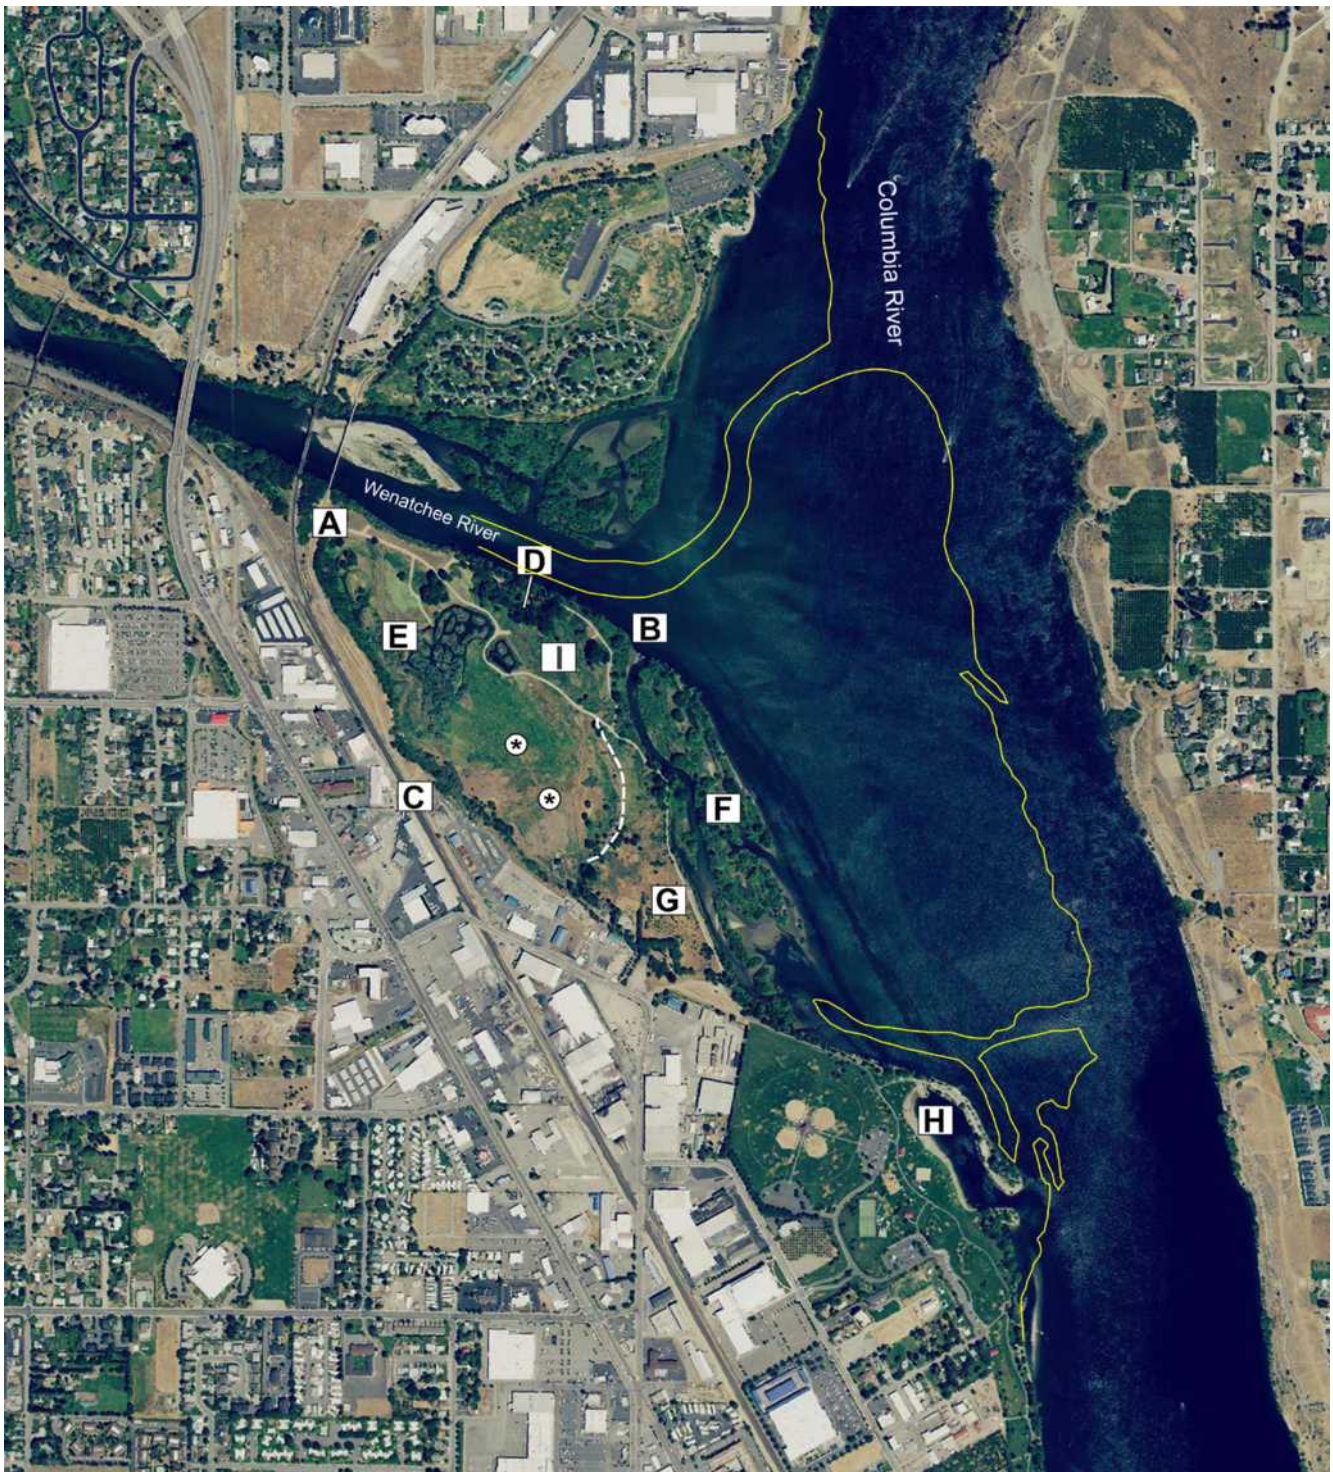
*Figure 31. The Wenatchee River delta in 2015*

This 2015 photo (Figure 31) is a good representation of the Horan Natural Area in 2020. Roughly 42% of the delta seen in the 1930 pre-dam photo (Figure 19) is now under water. The historic “otter paw” portion of the delta is invisible. Newcomers to the valley and visitors to the Horan Natural Area would never know the rich history of Indigenous Peoples in the area. The cottonwood groves are mature with little sign of new trees except on sites where tailings were piled during pond construction.
